# INSTRUCTION TO SERVICE

| ITS: 59166 | | 10-Feb-2021 |
| SUBJECT: | Inspect and replace BAE ISG mounting bolts | |
| ISSUE: | Existing ISG mounting bolts may be loose due to initial incorrect torque. | |

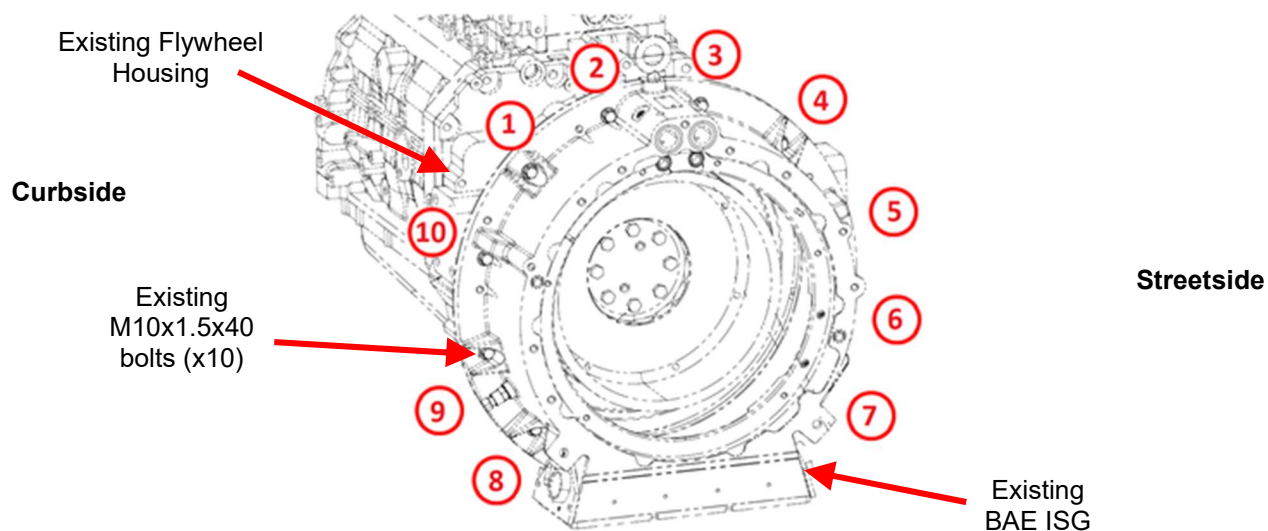
**Figure 2: BAE ISG Mounting Bolt Locations**

**⚠ WARNING:** If **ALL 10** bolts have torque stripes and **ALL 10** torque stripes are aligned, continue to the next Step. If **ANY** bolt is broken or has a missing or broken torque stripe, hold the bus from service and **contact your New Flyer RPSM for further instructions.**

5. Locate the BAE ISG mounting bolts as shown in Figure 2.

6. Remove one bolt at a time in a star pattern.
7. Use a thread chaser to clean the threads in the bellhousing, then use a blow gun to spray compressed air into the hole to clean the hole of any old Loctite or sealant.
8. Apply Loctite 243, p/n 081034 to the new bolt threads p/n 436616 and the internal threads of the mating holes in the flywheel housing and install.
9. Torque the new bolt to 54.6 +/- 5.5 lb-ft. and torque seal the bolt. See Figure 3 to show how the torque seal must be applied.
