# INSTRUCTION TO SERVICE

| ITS: 59173 | | 10-Feb-2021 |
| SUBJECT: | Inspect and replace BAE ISG mounting bolts | |
| ISSUE: | Existing ISG mounting bolts may be loose due to initial incorrect torque. | |

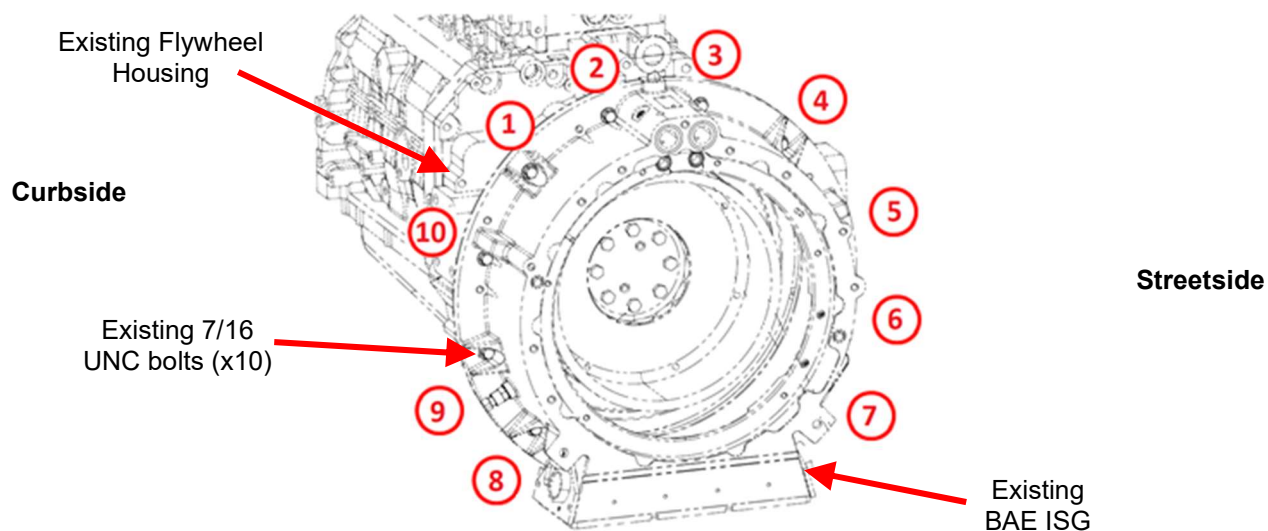
**Figure 2: BAE ISG Mounting Bolt Locations**

**⚠ WARNING:** If **ALL 10** bolts have torque stripes and **ALL 10** torque stripes are aligned, continue to the next Step. If **ANY** bolt is broken or has a missing or broken torque stripe, hold the bus from service and **contact your New Flyer RPSM for further instructions.**

5. Locate the BAE ISG mounting bolts as shown in Figure 2.
