MODEL
2019MY
Niro (DE HEV/PHEV)

NUMBER
211 (Rev 1, 02/23/2021)

TECHNICAL SERVICE BULLETIN

SUBJECT: **AEWP PARTIAL REPLACEMENT FOR DTC P2600/P0C73**

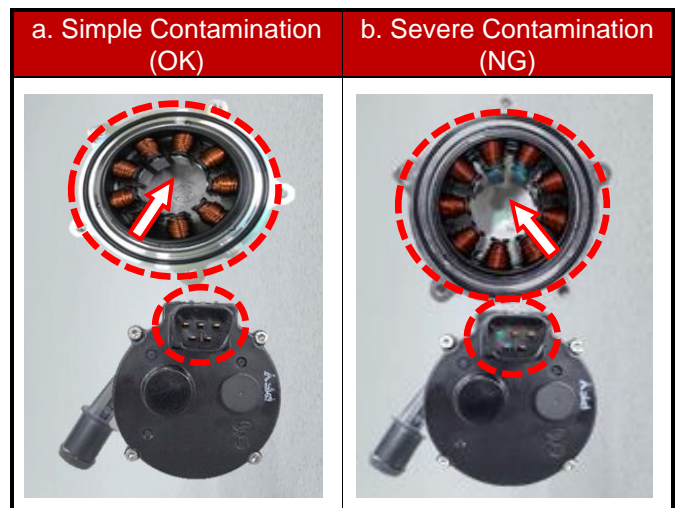
7. Check for coolant intrusion and terminal corrosion in the AEWP housing and take action according to the procedure and example photos.

- Simple contamination of the stator coil and power terminal:
Clean and dry the inside and replace the Kit parts (can case, S-ring, O-ring).
- Severe contamination of the stator coil and terminal:
Replace the AEWP assembly.

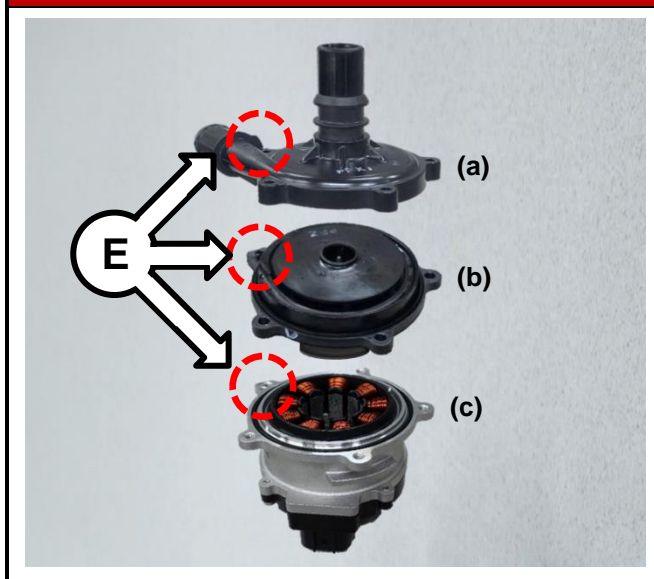
- Verify that O-ring is not stuck when assembling.
- Check assembly direction when assembling pump cover, can case, and housing. If center ball and holes do not align, the assembly will not fit correctly. (Refer to diagram at right.)

Fit "Center Ball" with "Hole" (E) when assembling Pump Cover (a) Can Case (b) and Housing (c).
