MODEL
2021MY
K5 (DL3a)

NUMBER
094 (Rev 1, 02/24/2021)

TECHNICAL SERVICE BULLETIN

**SERVICE ACTION: A/C DISCHARGE HOSE AND
SUNVISOR CLIP CONFIRMATION (SA441)**

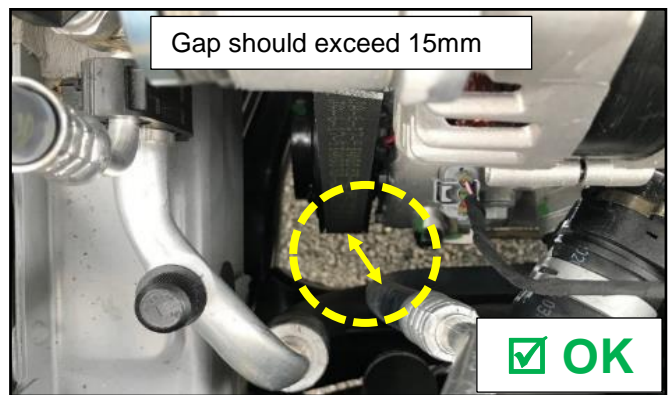
- 2b. Inspect A/C discharge hose for damage and confirm there is sufficient clearance (at least 15mm>) between the compressor pulley (D) and the discharge hose (E).

- 2c. If the clearance is not a minimum of 15mm proceed to Step 3.

If damage is present, replace A/C discharge hose by referring to the “Heating, Ventilation, and Air Conditioning → Air Conditioning System → Refrigerant Line → Repair procedures” chapter in the applicable Shop Manual on KGIS.

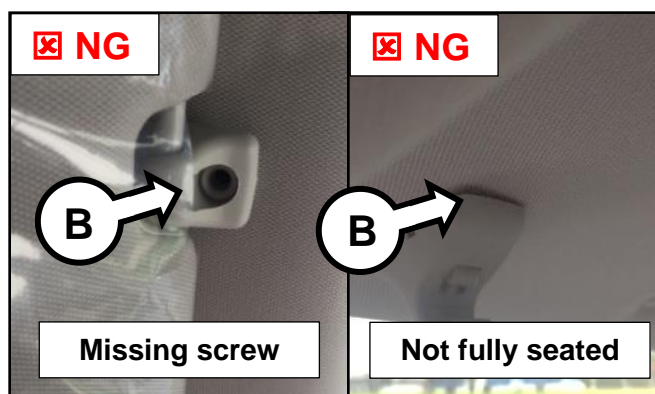
- 2a. Open and extend the sunvisor(s) and inspect the sunvisor retainer clip (B) for poor seating against the headliner.

- 2b. If the retainer clip is not seated correctly, re-install the retainer (B) to the headliner.

If the retainer clip is missing the retaining screw, install the missing screw using P/N: 85289 3V000.

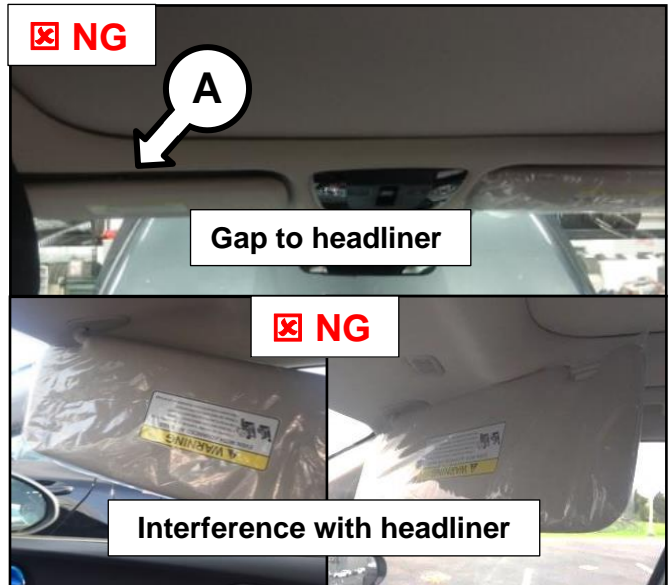
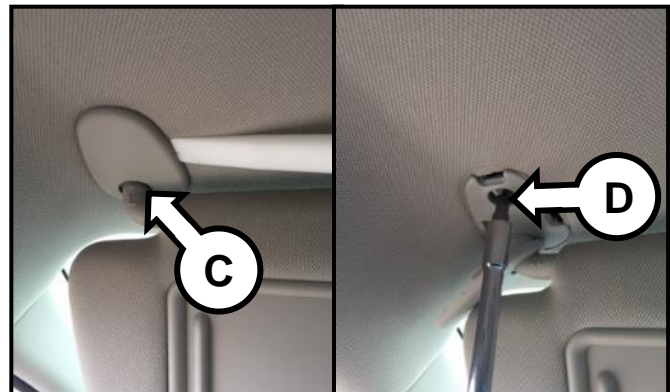
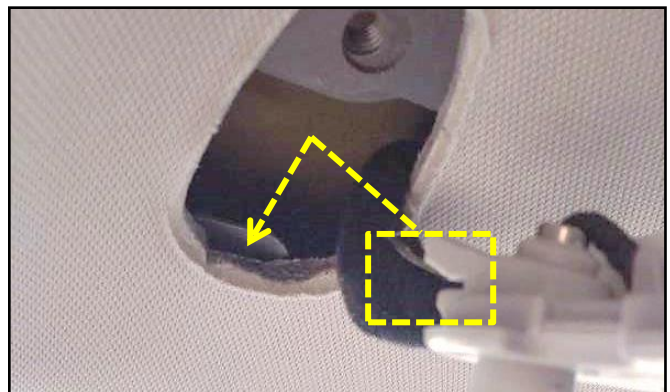
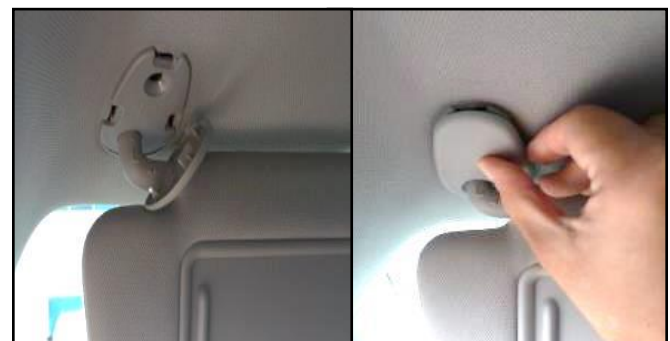
- 2c. Inspect the condition of the sunvisor (A) seated to the headliner. The following conditions may occur if not seated correctly to the headliner:
1. Sunvisor will not fold up all of the way.
 2. Sunvisor feels loose at the base when opening and closing the sunvisor.
 3. Sunvisor does not sit horizontal from the base when unclipped from the retainer.
- 3a. If the sunvisor is secure, functions and appears normal, then this service action is complete.
- 3b. If an issue is found during the inspection, remove trim cover (C) from the sunvisor pivot point.
4. Remove the retaining screw (D), to remove the sunvisor.
- 5a. Re-install the sunvisor to body flange first prior to seating it to the headliner.
- 5b. Tighten the sunvisor retaining screw (D) from step 3d to secure the sunvisor.
- 6a. Re-install the screw trim cover.
- 6b. Confirm the sunvisor function and appearance.
