### **Quality information – AV133 axle, suspect screws used in flange shaft connection**

# AV133 Suspect screws at flange shaft connection

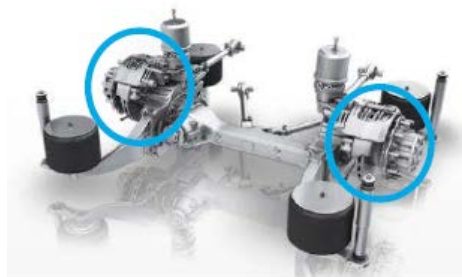
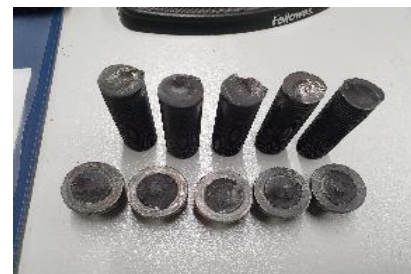
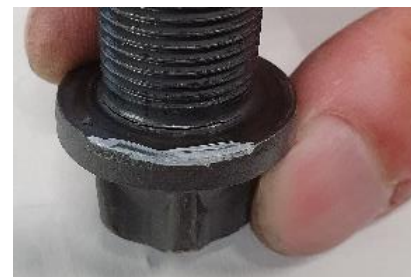
In July 2020 torx screws broke in Passau assembly line. During intensive root cause investigation together with the screw-supplier it was identified as a supplier caused failure due to a faulty pressing tool. Affected time period is between April to September 2020. The affected type of screw is used for the flange shaft connection of the AV133 city bus axle which is classified as risk class B acc. to VDI 2862.

- Part no.: 0750.108.991
- Properly class: 10.9
- Dimension: M18x1,50x45,0
- Applied torque: 440 Nm

20 screws per axle used for the hub-flange shaft connection

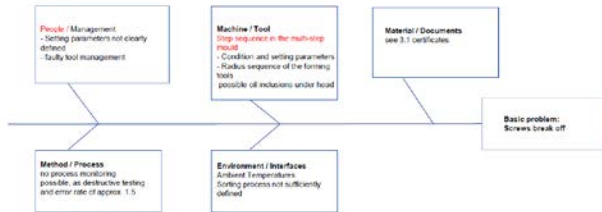
### D 4 Fault Causes

- Supplier has analyzed issue with ISHIKAWA and 5Why
- Root cause has been identified – worker error and usage of faulty tool (wrong radius 0,8mm during forming step 3)
- Failure has been reproduced at supplier
- Sorting actions on suspect batches showed failure rates between 1,37% (screw .991) and 3,13% (screw .691)

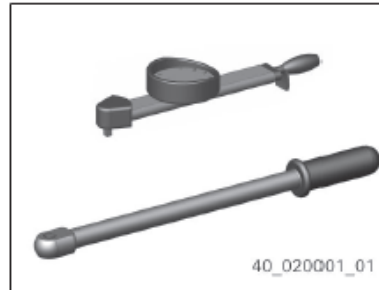
Screws with potential cracks used for the flange shaft connection on AV133 city bus axles

Supplier caused failure due to bad tooling

Change of the 20 potentially affected screws per axle

Old screws shall be scrapped after the rework

20 pcs. Torx screw 0750.108.991

Torque wrench 5870.203.016 (140 Nm to 800 Nm)
