SERVICE INFORMATION BULLETIN

APPLICABILITY: 2019-21MY Crosstrek Plug-In Hybrid **NUMBER:** 12-310-21
 2015-16MY Crosstrek Hybrid **DATE:** 02/11/21
SUBJECT: Refinishing and Collision Repair Precautions

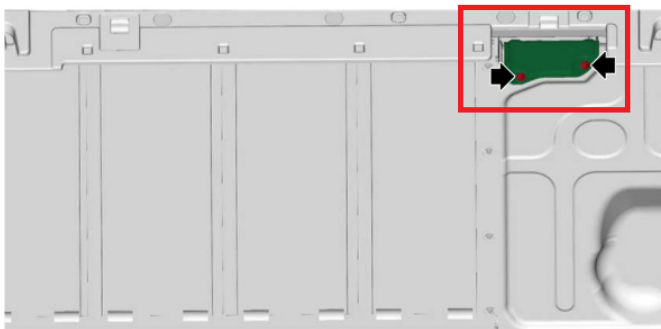
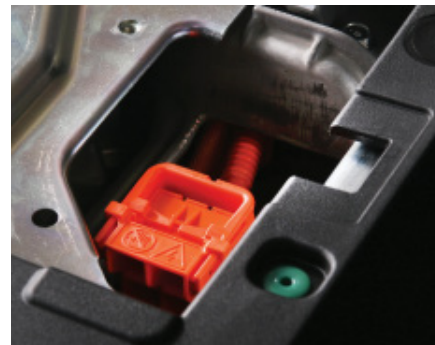
For Crosstrek PHEV (2019-21MY) vehicles:

- Disconnect the negative (-) ground terminal from the battery.
- Remove the rear cargo area floor mat.
- Remove the access cover for the orange Safety Plug.

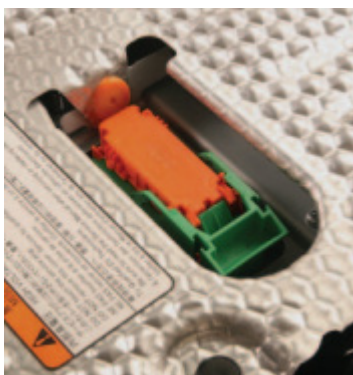
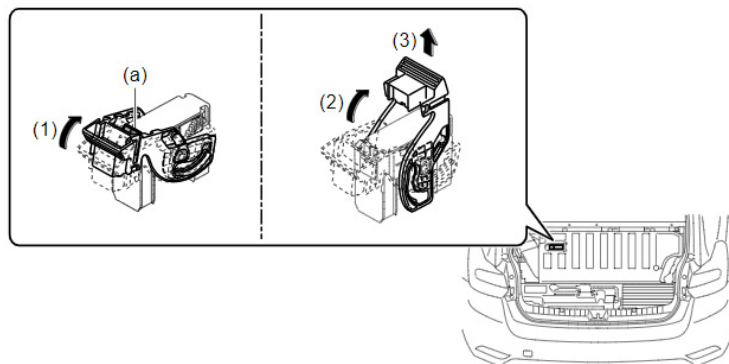
For Crosstrek Hybrid (2015-16MY) vehicles:

- Disconnect the negative (-) ground terminal from the battery. For the 12v restart battery, disconnect the negative (-) ground cable from the battery sensor. **IMPORTANT:** Whenever reconnecting the ground cable, torque the 12mm retaining nut to 7.5 Nm / 5.5 ft. lbs. (66 inch-pounds) while holding the sensor securely in position on the battery post to prevent it from rotating. **DO NOT OVER-TORQUE.**
- Remove the rear cargo area floor mat.
- Remove the orange Service Disconnect Plug as shown:
 - While pressing lock claw (a), pull up on the lever until it touches the stopper.
 - Pull straight up on the orange Service Disconnect Plug to remove it from the battery.
