SERVICE BULLETIN

APPLICABILITY: 2020MY Legacy and Outback **NUMBER:** 07-189-21
SUBJECT: Front Door Window Regulator- Erratic Operation **DATE:** 02/15/21

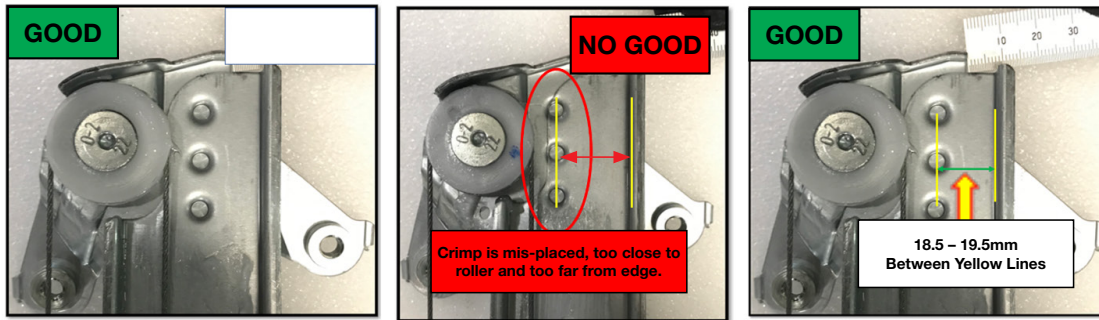
STEP 2: Measure the regulator upper roller frame to confirm the crimping process was performed in the proper location as shown in the comparison photos below. If the crimp is out of position, the window regulator assembly must be replaced.

- In the NO GOOD photo above, the crimp tool edge has contacted the 3 “dimples” and the gap between them and the edge shown in the “GOOD” photos is exceeds 19.5mm. If EITHER of these conditions is identified, the window regulator assembly must be replaced.

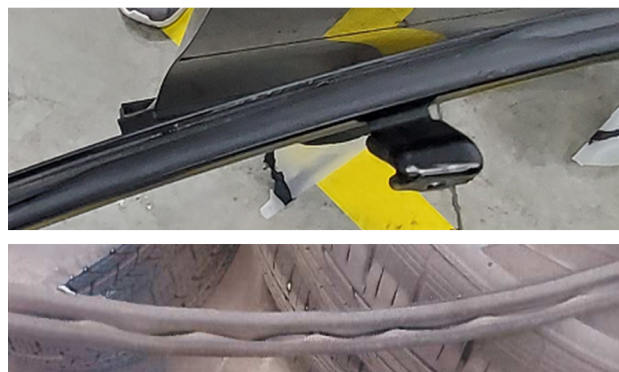
STEP 3: Inspect the glass run channel AFTER regulator replacement is complete. If it is physically damaged or does not allow proper function of the regulator / glass, it must be replaced. Photos of damaged glass run channels are supplied below for reference.

When inspection determines replacement is required, the service procedures for window regulator assembly and glass run channel replacement remain unchanged. Always refer to STIS and review the full requirements of the repair being performed. The Service Manual procedures contain information critical to performing an effective repair the first time, every time. This includes but is not limited to important SAFETY precautions, proper inspection criteria, necessary special tools, required processes and related one-time-use parts needed for a complete and lasting repair.
