SERVICE PROGRAM BULLETIN

APPLICABILITY: 2020-2021MY Legacy and Outback **NUMBER:** WRI-20R
SUBJECT: Reprogramming of Denso CP1 Infotainment Units to Optimize System Performance **DATE:** 12/11/20
REVISED: 02/15/21

In the interest of customer satisfaction, Subaru of America, Inc. (Subaru) is initiating a Service Program for certain 2020-2021 model year Legacy and Outback vehicles to update the Cockpit Control Module (CCM) software to the latest version.

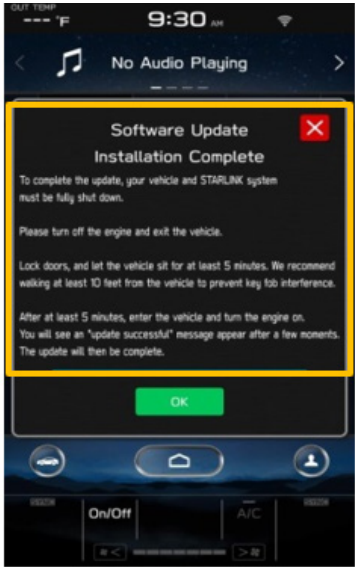
- Clarification of the post-FOTA procedure instructions required to complete the update. The screenshot below will appear and explain what must be done to complete the update installation.
