PRODUCT CAMPAIGN BULLETIN

APPLICABILITY: 2020MY Legacy and Outback

NUMBER: WRH-20R

SUBJECT: Rear Visibility FMVSS 111 Non-Compliance

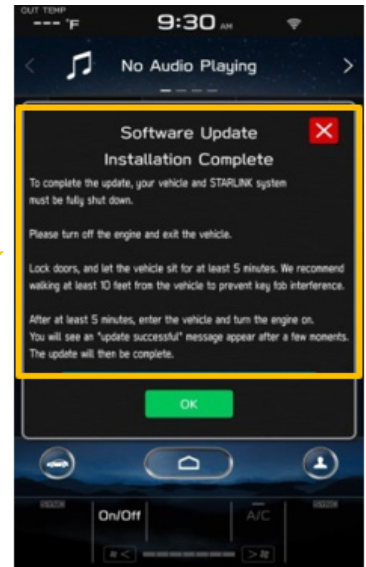
- Clarification of the post-FOTA procedure instructions required to complete the update. The screenshot below will appear and explain what must be done to complete the update installation.

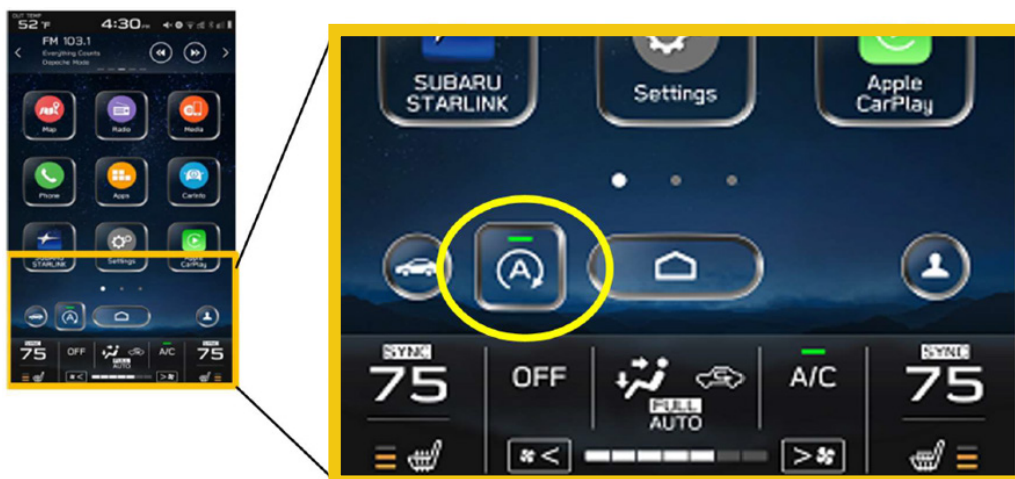
The Auto Stop-Start On/Off function button has been moved from the bottom to top layer of the system for easier use. A screenshot of how the button will appear is shown below.

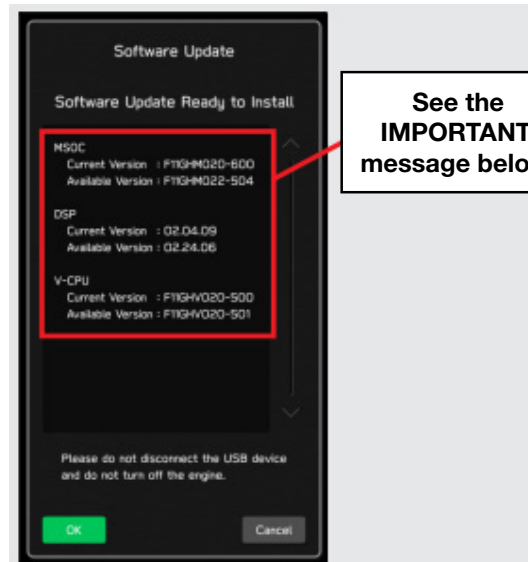
6f) The screen below will be displayed. **NOTE:** The actual software version displayed will be different from the EXAMPLE picture shown below.

Confirm the MSOC Available Version listed here matches with what is shown on the CID.

If it does not match the Available Version shown on the CID Screen STOP and load the correct file to the USB Drive.

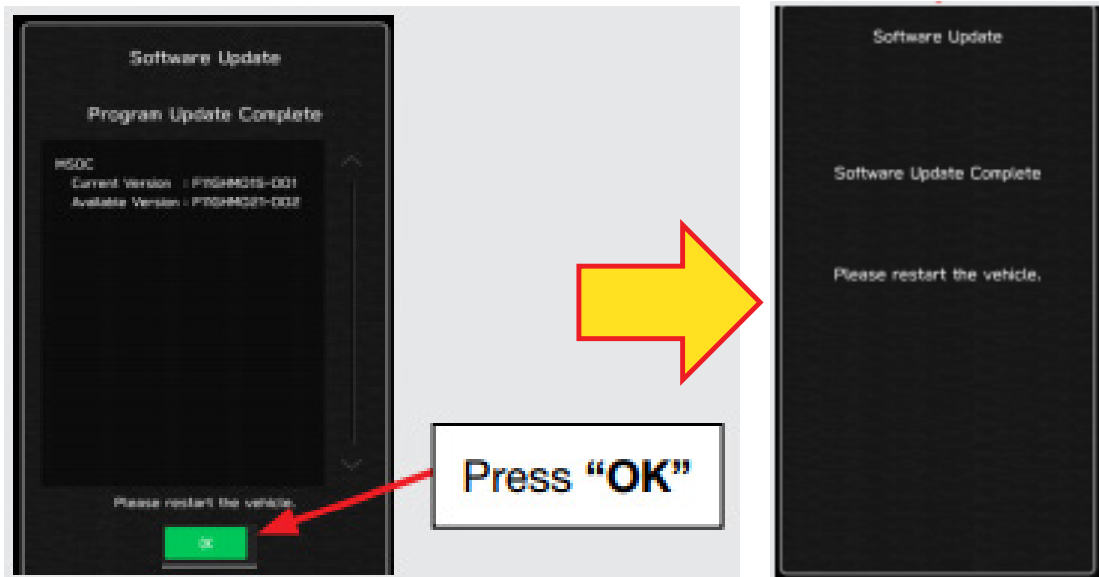
6h) When the update is complete, the screen below will be displayed (the actual software version number will be different).

IMPORTANT NOTE: On rare occasions a “Software Update Incomplete” message may appear in this step which occurs due to a bug in the software update procedure. **DO NOT** attempt to install the update again, proceed to **6i)** below to confirm the software version has been updated to the latest version.

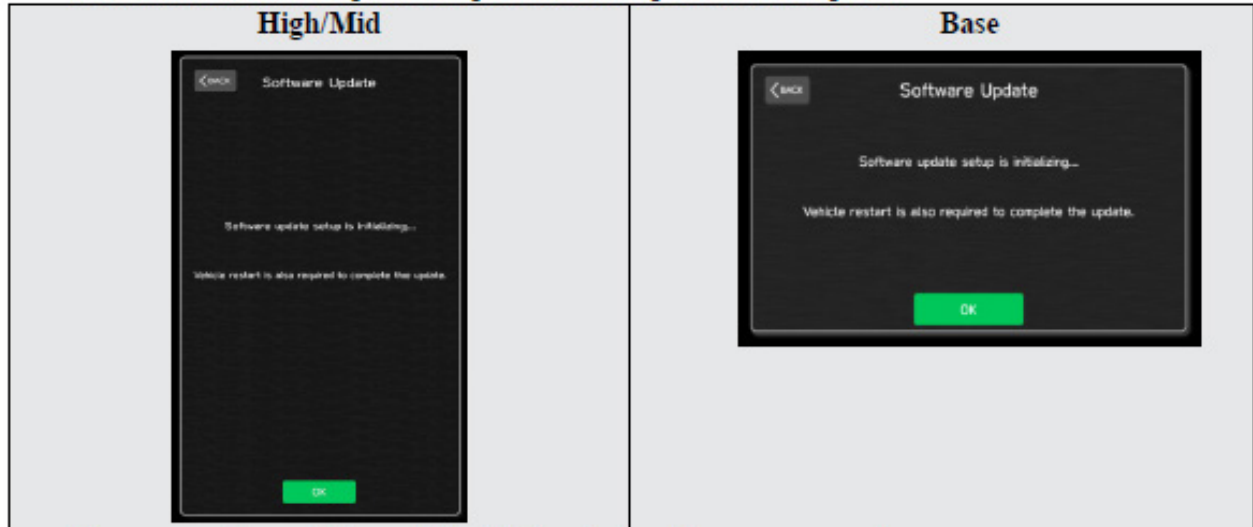
- If the screen shown below appears, **WAIT** for approximately 15 minutes or as long as necessary to allow the Software update setup initialization process to complete.

1. Turn the ignition OFF, open the driver's door, close the driver's door and **WAIT** for 3 or more minutes before proceeding further.
2. Open the driver's door again and either turn the ignition ON (if a charger is connected) or start the engine.
3. Go to Dealership Mode menu again (PRESS and HOLD the RIGHT-side temperature control buttons (both up and down) and press the Tune / Scroll knob 6 times then release all to display the Dealership Mode) and select Software Update as in STEP 3 beginning on pg. 8.

IMPORTANT NOTE: If this procedure is required, contact Techline as additional action may be necessary.
