## Technical Service Information Bulletin

### 2.0 Superstructure Support Drain Hole

**Bulletin Name:** FDM-TSIB-020

**Model:** Oshkosh S-Series

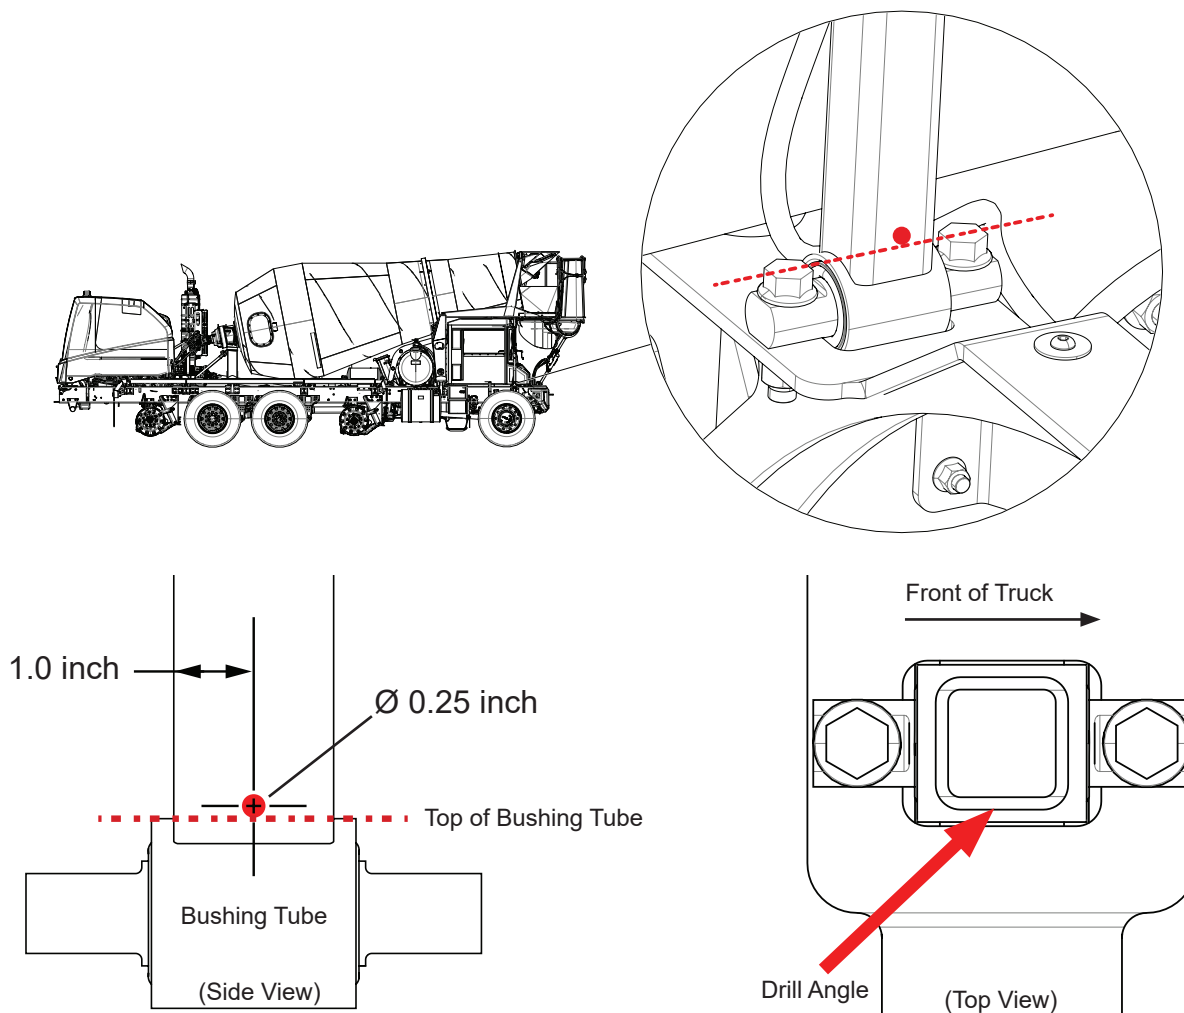
Figure 2 Right-Hand Super Structure Support

This bulletin provides instruction for drilling a drain hole near the base of the left and right superstructure supports to allow any water that enters the support to drain. Trapped water in the superstructure support can freeze in cold weather causing the support to rupture at the base. Current production superstructure supports now have a drain hole.

4. Measure and mark the drain hole location on the right-hand superstructure support, see Figure 2.
5. Punch the drain hole location in the superstructure support using hammer and metal punch.

**Do not drill into the bushing tube while drilling the superstructure support. Drilling into the bushing tube will cause damage and require replacement of the superstructure support.**

6. Drill drain hole parallel with the ground and angled toward the rear of the truck. See Figure 2.
