SERVICE INFORMATION BULLETIN

APPLICABILITY: All Models with Gen1 and Gen2 Telematics **NUMBER:** 15-278-21
DATE: 02/25/21
SUBJECT: Telematics DTC B2A01- Diagnostic Best Practices

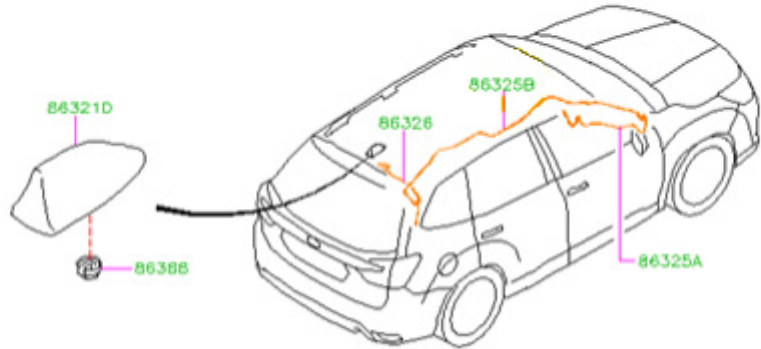
Figure 01

Should the Technician get to the point in the trouble tree where DVOM measurements indicate a faulted antenna cable and replacement is necessary, extra steps should be taken to isolate each of the antenna path sections further to ensure the correct cable section is ordered. **Figure 01** below illustrates there are 3 sections of cable making up the antenna path. The trouble tree for the model in the example has all testing from the connections at the DCM and the Sharkfin. It is also worth noting, one of the antenna sections is described as a Feeder Cord Assembly with no mention of the antenna.

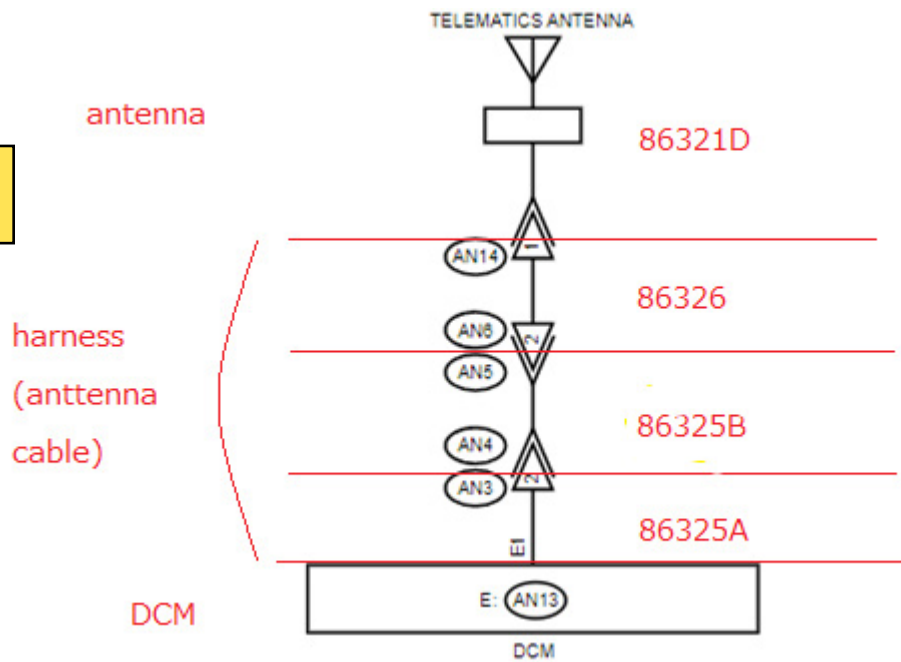
Figure 02 (FORESTER)

Figure 02 below illustrates the Forester cable section connection points so the Technician can easily see further isolation is possible even though it is not detailed in the trouble tree. Isolation (or “split-half technique”) testing using the same method as the trouble tree must take place at each additional connection point to isolate the faulted section.

In order to ensure the best repair outcome possible and avoid replacement of unnecessary parts, use the table below to isolate the additional testing points on other models when diagnosing B2A01.
