SERVICE BULLETIN

APPLICABILITY: 2018-21MY Crosstrek **NUMBER:** 12-311-21
SUBJECT: Side Cowl Panel Trim- Design Change **DATE:** 02/25/21

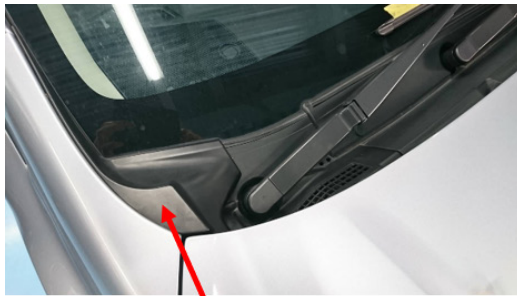
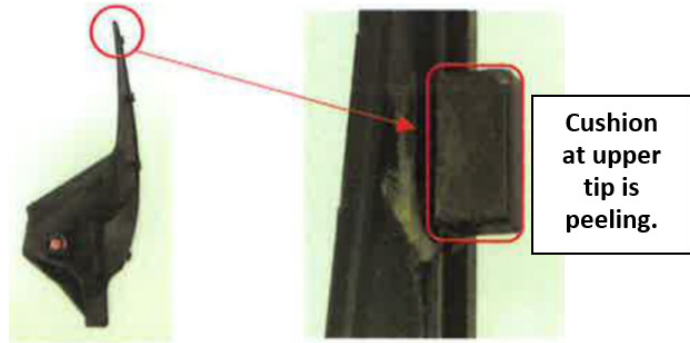
This bulletin announces a design change made to the windshield side cowl panels to address isolated concerns of a buzzing / rattle -type sound heard while driving. The size of the foam cushion portion and the production process to secure it to the part have been optimized to prevent the condition.

The new COWL PANEL-SIDE trims were incorporated into Crosstrek production starting with VIN **MH277078**.

Description	Part Number
COWL PANEL- SIDE, RIGHT	91423FL001
COWL PANEL- SIDE, LEFT	91423FL011
