# Technical product information

<b>Topic</b>	Bentayga V8 Kovomo - DTC P304300 with symptom code (10061) - Fuel Pump Mechanical Malfunction - MIL lamp
<b>Market area</b>	Russische Föderation (5RU),Australia E04 Bentley rest Asia and Australia (6E04),China 796 VW Import Comp. Ltd (Vico), Beijing (6796),Germany E02 Bentley rest Europe (6E02),Japan E03 Bentley Japan (6E03),Korea, (South) E08 Bentley South Korea (6E08),United Arab Emirates E06 Bentley Middle East and Africa (6E06),United Kingdom E01 Bentley UK (6E01),United States E05 Bentley USA and rest America (6E05)
<b>Brand</b>	Bentley
<b>Transaction No.</b>	2062092/1
<b>Level</b>	EH
<b>Status</b>	Approval
<b>Release date</b>

## Bentayga - V8 Kovomo

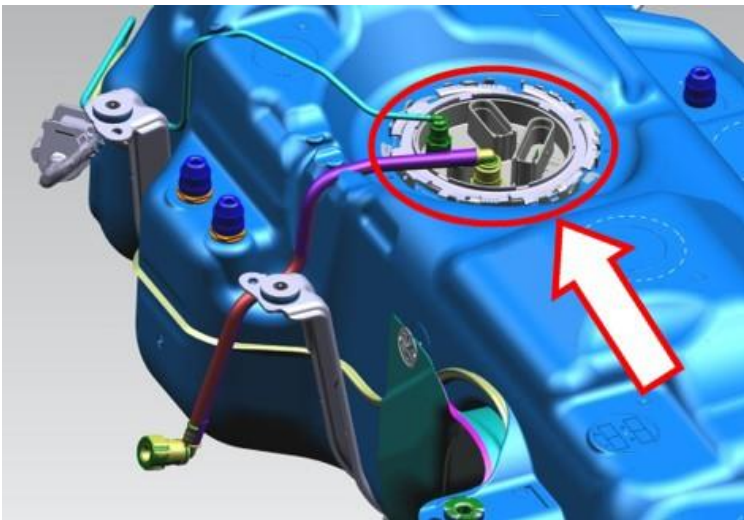
Figure 1

4) Conduct a visual inspection of the fuel pump delivery module (Top) for any obvious signs of damage (Figure 1)

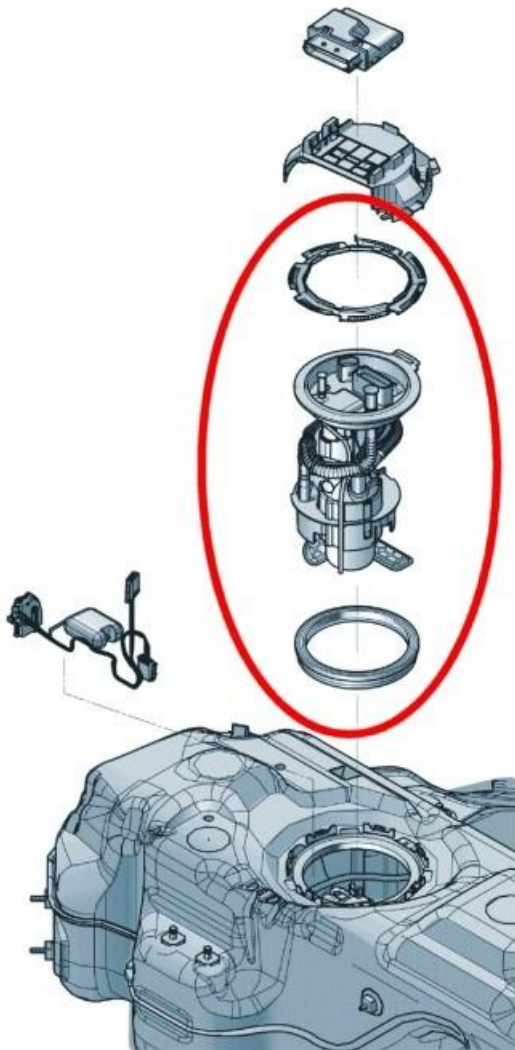
Figure 2

DTC P304300 – with symptom code (10061) - Fuel Pump Mechanical Malfunction evident

5) Should all the advised checks detailed in steps 1 to 4 be to specification – Replace the Fuel Delivery Module within the fuel tank (Figure 2) - Refer to Repair Group 20 Fuel supply, gas operation / 4.0L V8 TSI / Fuel pump, fuel level sensors, and jet pump (RH) – To remove and fit
