SERVICE INFORMATION BULLETIN

APPLICABILITY: 2010-21MY Legacy
 2008-21MY Impreza
 2008-20MY WRX
 2008-20MY WRX STI
 2013-20MY BRZ
 2019-21MY Ascent
 2006-14MY Tribeca

NUMBER: 05-83-21

SUBJECT: Rear Sub Frame Bolts- Design Change

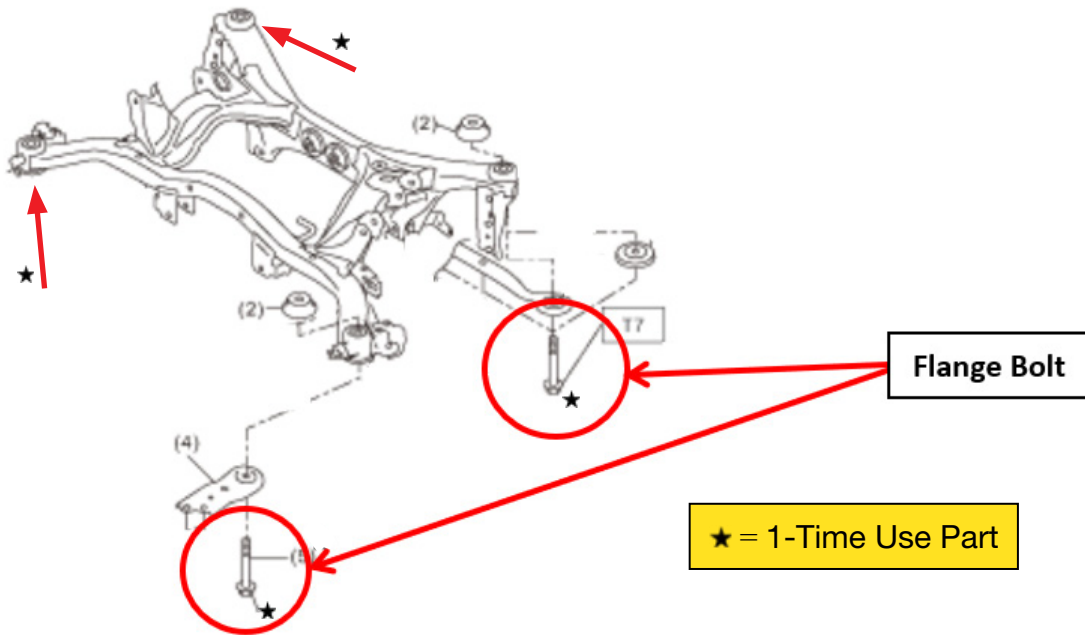
This Service Information Bulletin announces design changes made to the rear sub frame retaining bolts. water drainage grooves have been added and the bolt head flange thickness has been increased for purposes of part unification with other models. These 4 (four) main bolts secure the rear sub frame into the vehicle.

IMPORTANT: These sub frame bolts are **one-time use** items as indicated by the black star in the Service Manual and the illustration above. Anytime these bolts are removed, they must be replaced.

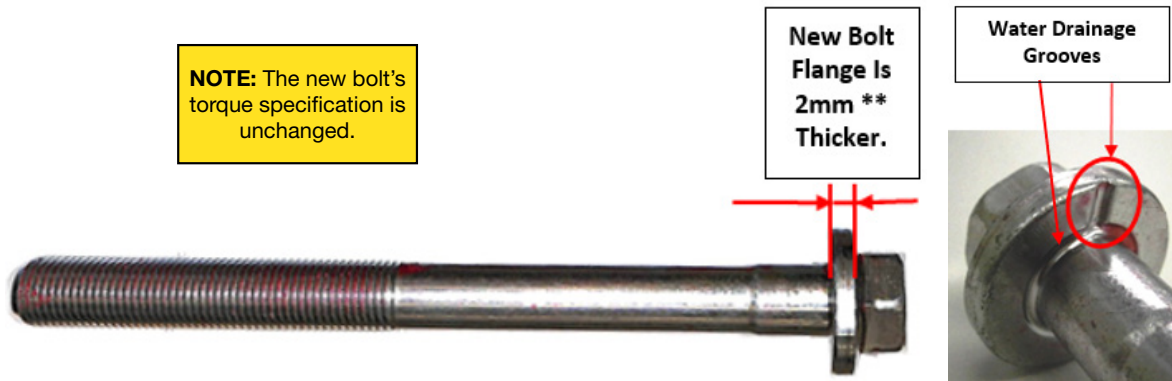
REMINDER: Always order the most up-to-date replacement parts based on the specific VIN being repaired. The changes made to the sub frame bolts are outlined in the illustrations below.

- For SBR / Japan-produced vehicles, the new sub frame bolt's part number is: **20058FL020**.
- For SIA -U.S. produced vehicles, the new sub frame bolt's part number is: **20058AL00B**.

- All models **EXCEPT** Tribeca: 145 Nm (107 ft. lbs.)
- Tribeca: 95Nm (70 ft. lbs.)
