Technical product information

Topic	Water ingress – hood stowage area - high mounted stop lamp
Market area	Bentley: worldwide (2WBE)
Brand	Bentley
Transaction No.	2035817/2
Level	EH
Status	Approval
Release date

Water leaks into hood stowage area

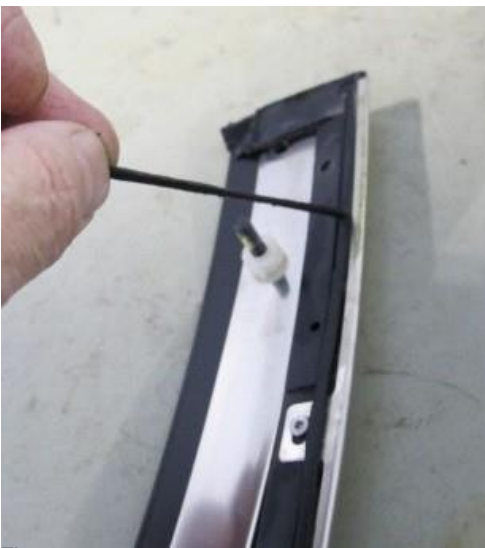
Figure 1

Seal failure between the brightware containing the high mounted stoplamp, and the tonneau cover, can lead to water ingress into the hood stowage area

2. Remove the original seal and thoroughly clean the surface on which the new seals will be positioned (see Figure 1)
