Technical product information

Topic	Keyless door entry does not work - Front Outside Door Handle - Touch Sensor DTC present within address 0046
Market area	Russische Föderation (5RU),Australia E04 Bentley rest Asia and Australia (6E04),China 796 VW Import Comp. Ltd (Vico), Beijing (6796),Germany E02 Bentley rest Europe (6E02),Japan E03 Bentley Japan (6E03),Korea, (South) E08 Bentley South Korea (6E08),United Arab Emirates E06 Bentley Middle East and Africa (6E06),United Kingdom E01 Bentley UK (6E01),United States E05 Bentley USA and rest America (6E05)
Brand	Bentley
Transaction No.	2062257/1
Level	EH
Status	Approval
Release date

New Continental GT/GTC

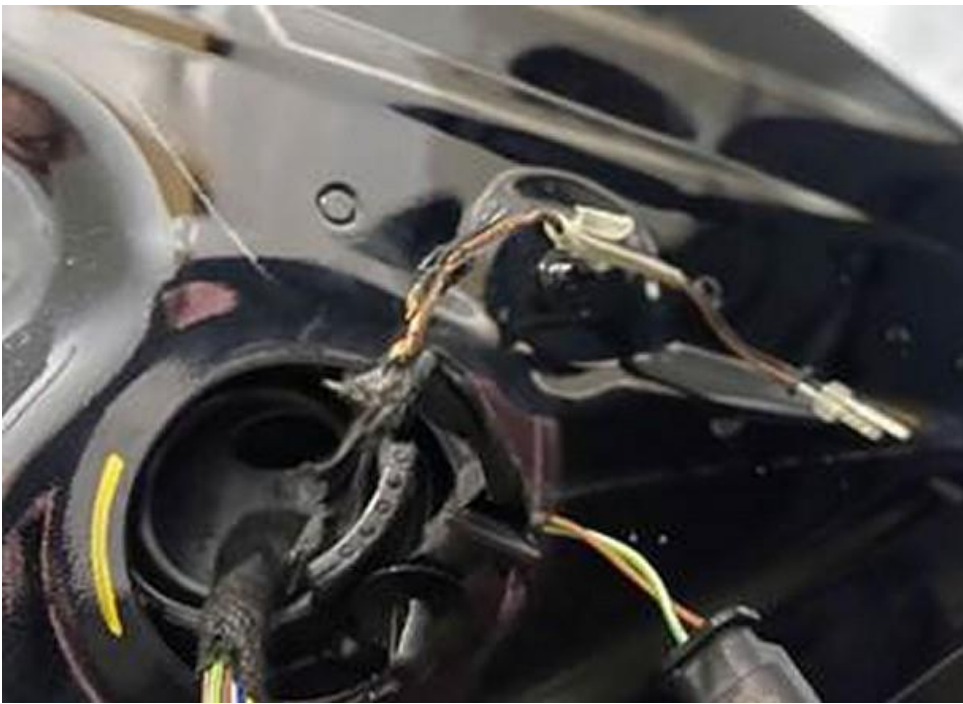
Figure 1

- Referring to Figures 1 and 2 - Perform a check of the wiring that is routed through the exterior door handle (from the convenience control module), including the wiring inside the clear heat shrink or insulating tape
- In the event that any wires show damage or signs of chaffing/breaks continue with the suggested repair as detailed in Step 3

3) Repair the broken or damaged wires as per Rep.Gr97

TIP: Where possible, extend the length of the wires by 10mm

- Ensure the wiring does not clash with and components in particular the window mechanism
