# Technical product information

<b>Topic</b>	Various and/or numerous Transmission control module DTC's logged - V8 Kovomo engine
<b>Market area</b>	Russische Föderation (5RU),Australia E04 Bentley rest Asia and Australia (6E04),China 796 VW Import Comp. Ltd (Vico), Beijing (6796),Germany E02 Bentley rest Europe (6E02),Japan E03 Bentley Japan (6E03),Korea, (South) E08 Bentley South Korea (6E08),United Arab Emirates E06 Bentley Middle East and Africa (6E06),United Kingdom E01 Bentley UK (6E01),United States E05 Bentley USA and rest America (6E05)
<b>Brand</b>	Bentley
<b>Transaction No.</b>	2061288/2
<b>Level</b>	EH
<b>Status</b>	Approval
<b>Release date</b>

## New Continental GT/GTC - New Flying Spur - V8 Kovomo

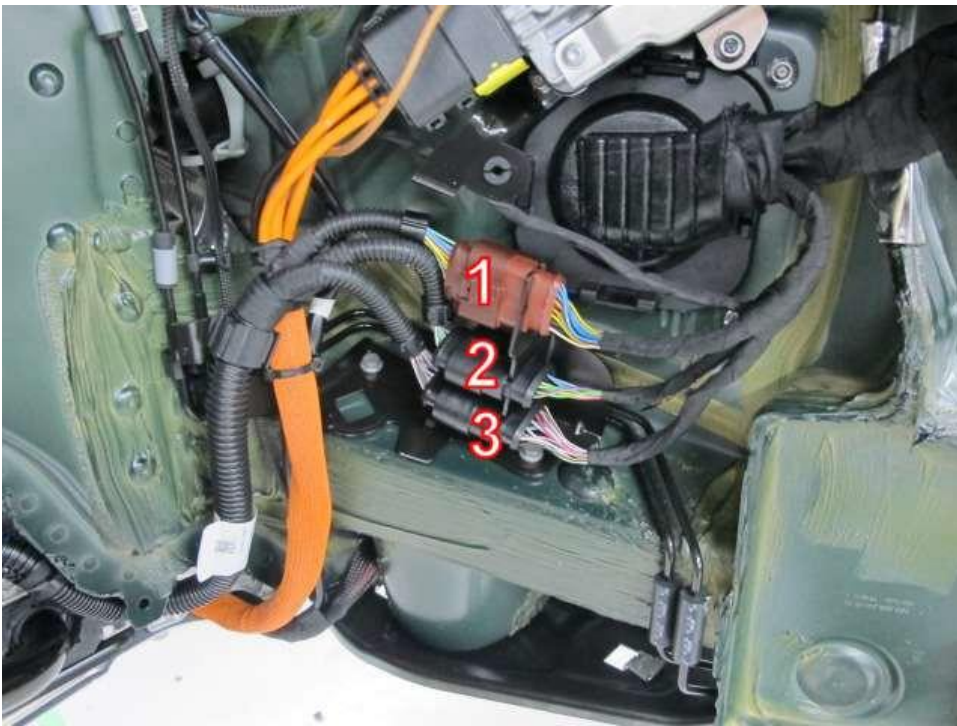
- Referring to Figure 2 - Disconnect the three connectors shown

2) Once disconnected carry out pin/terminal grab checks on all three male and female connections

- In the event the main vehicle harness pins are not to specification the applicable pins should be replaced
- Should any issues be found with the transmission link harness and/or pins – the harness should be replaced

- In the event the pins are to specification or the applicable repairs have been done (for example - Harness replacement or pin replacement)
  - Reconnect all three connectors (Figure 2) and proceed to Step 3

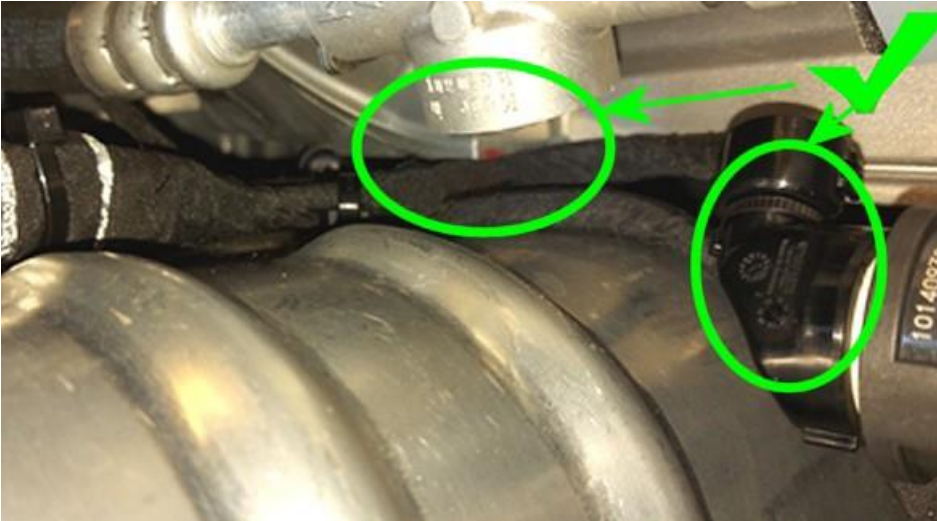
5) Check and confirm the link harness in Figure 4 is routed correctly as shown

- Figure 4 shows the correct routing of the link harness in relation to the automatic transmission fluid thermostat (*Harness not in contact*)

with the thermostat) and also the correct orientation of the transmission multi plug

IMPORTANT: Should any issues be suspected regarding the link harness routing as detailed, The operative MUST raise a DISS query and await feedback before conducting any further work

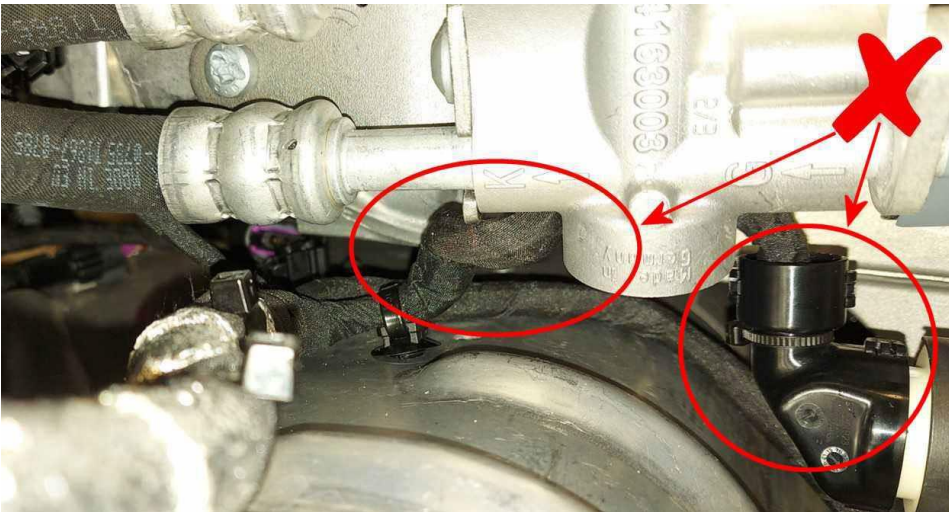
- Figure 5 shows the incorrect routing of the link harness in relation to the automatic transmission fluid thermostat (*Harness in contact with the thermostat*)
- Figure 5 also shows the incorrect orientation of the transmission multi plug

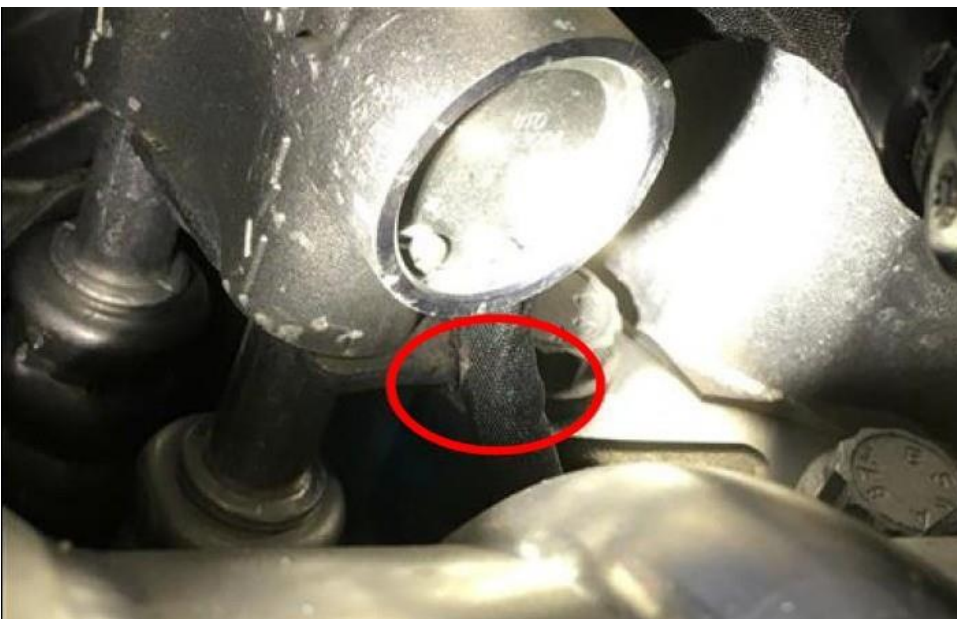
- Referring to Figure 6 - Check the location of the link harness in relation to the thermostat bracket
