Technical product information

New Continental GT /GTC and New Flying Spur

Air suspension warning light within the DIP - DTC P089200 – Symptom Code 3145792 evident within Address 74

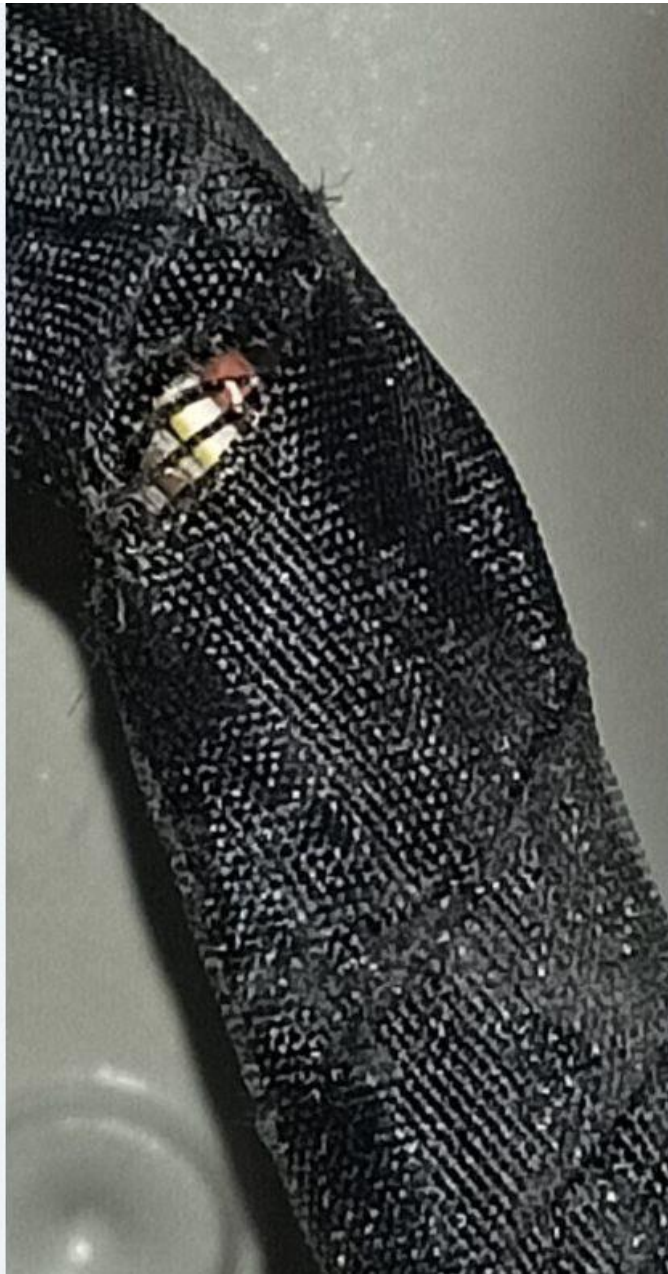
TIP: Previous instances have highlighted the following after inspection:

- Broken wires
- Kinked wiring
- Pin/s missing
- Pin/s broken
- Pin/s loose

NOTE: Refer to the example shown in Figure 1 of a damaged wiring harness

2) Repair any broken or damaged wires as per Rep. Gr 97
