Technical product information

| Brand | Bentley |

New Continental GT/GTC and New Flying Spur

Electronic Parking Brake (EPB) functionality issues found at Pre Delivery Inspection (PDI)

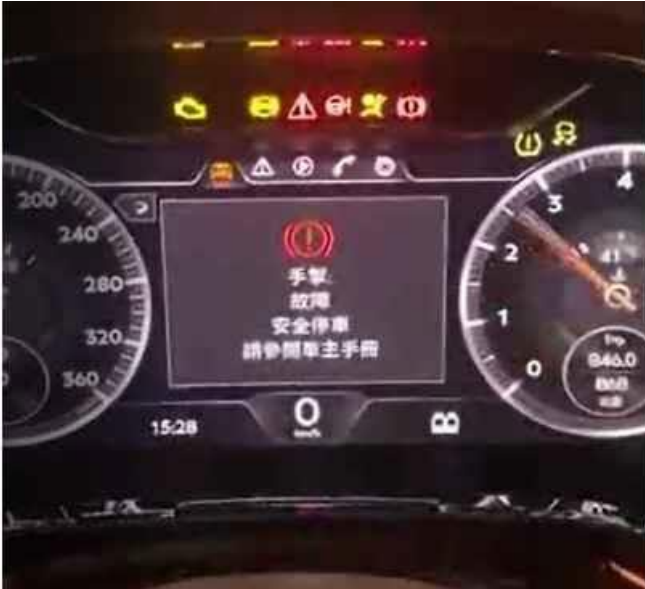
Figure 1

- Electronic Parking Brake (EPB) found not operating to specification during the Pre Delivery Inspection (PDI)
- EPB may not hold the car effectively
- Parking brake warning light may also be evident within the DIP (See example shown in Figure 1)
