<b>HYUNDAI</b> <b>Technical Service Bulletin</b>	<b>GROUP</b> <b>BODY ELECTRICAL</b>	<b>NUMBER</b> <b>21-BE-002H</b>
	<b>DATE</b> <b>FEBRUARY, 2021</b>	<b>MODEL(S)</b> <b>ELANTRA (CN7, CN7a)</b> <b>SONATA (DN8)</b> <b>SONATA HYBRID (DN8 HEV)</b> <b>PALISADE (LX2)</b> <b>VENUE (QX)</b>
<b>SUBJECT:</b> WIRELESS CARPLAY SOFTWARE UPDATE

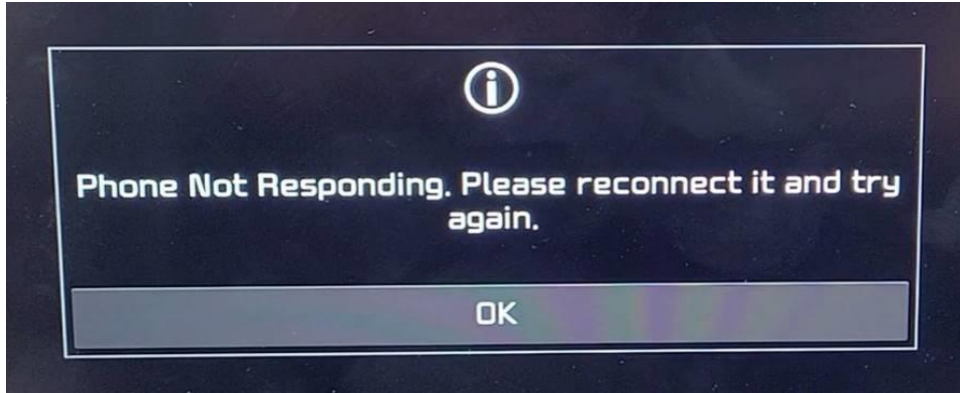
**Description:** When using Wireless CarPlay, the system may intermittently auto disconnect. When Wireless CarPlay is disconnected, a pop up message “Phone Not Responding. Please reconnect it and try again” will appear on the radio screen.

**Note:** The disconnection phenomenon is caused by the Apple IOS software. Apple IOS software intermittently pause the data transmission, causing the communication interruption between the radio and CarPlay. This software update helps reduce the disconnection occurrences, until Apple provides a software update to correct the condition.

This bulletin describes the procedure to update the radio software to help reduce the disconnection occurrences.
