# TECHNICAL SERVICE BULLETIN

Technical Service Bulletin: 53-1303

# TECHNICAL SERVICE BULLETIN 53-1303 REMEDY INSTRUCTIONS

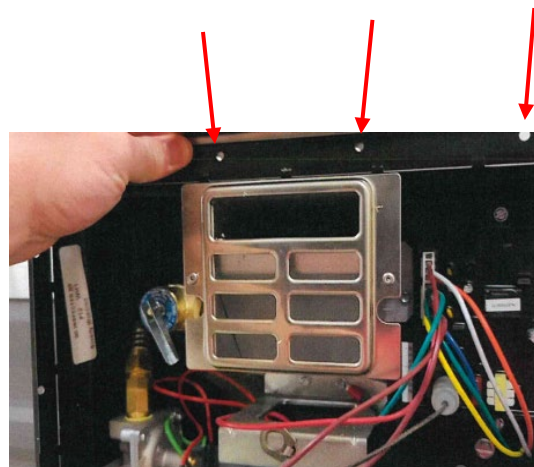
Figure 1

The water heater exhaust is too close to the refrigerator access door and excessive heat could cause the refrigerator access door to melt.

| | Concern: The installation of the optional LP/Electric refrigerator is located too close in proximity to the water heater and the heat from the water heater exhaust has the potential to cause deformation to the refrigerator vent. | Photo(s) Required: No<br>Prior Authorization Required: No<br>Part(s) Number: N/A<br>Part(s) Return: No |

1. Make sure the water heater is disabled and the exhaust plate is cool to the touch.
2. Remove the Dometic water heater access door.
3. Remove securement OEM fasteners from the top of the water heater and place aside to reuse. Figure 1.
4. Carefully fold the top black flange of the water heater outward approximately 1/4" to 3/8".
5. Apply appropriate butyl tape or sealant to rear of the provided heat deflector covering the deflector's screw holes. Figure 2.
6. Insert heat deflector between black flange of the water heater and the sidewall. Make sure to center it over the exhaust plate with the holes aligned with the factory mounting holes. Figure 3.
7. Bend the black flange of the water heater back against the sidewall and reinstall OEM fasteners.
8. Reinstall water heater access door.
