# Technical product information

| Topic | Convertible hood cannot close - Header trim flap eyelet broken |
| Brand | Bentley |

## New Continental GTC

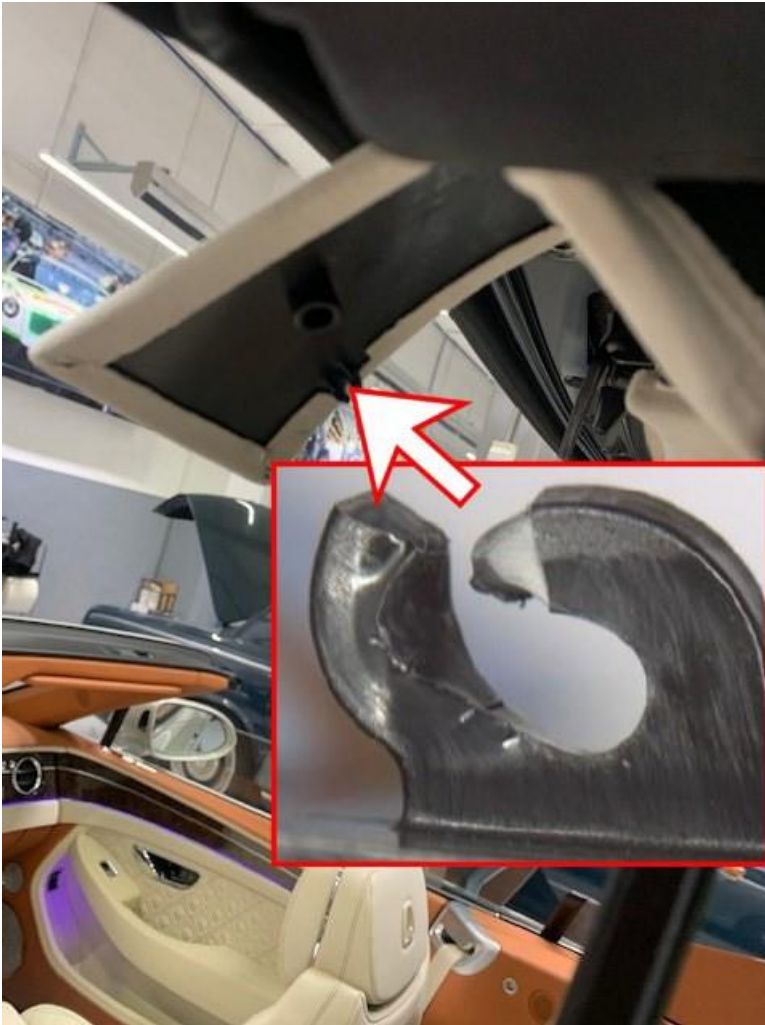
Figure 1

Convertible hood cannot close/latch due to a broken eyelet. The eyelet is part of the trim flap assembly (Figure 1)
