**Model:** V9 Bobber MY16 MY17 - V9 Bobber E4 MY17 - V9 Roamer MY16 MY17 - V9 Roamer E4 MY17

**Subject:** ABS lines tightening adjustment - Technical update

**Campaign Code:** PGJZZQ1701\_TU

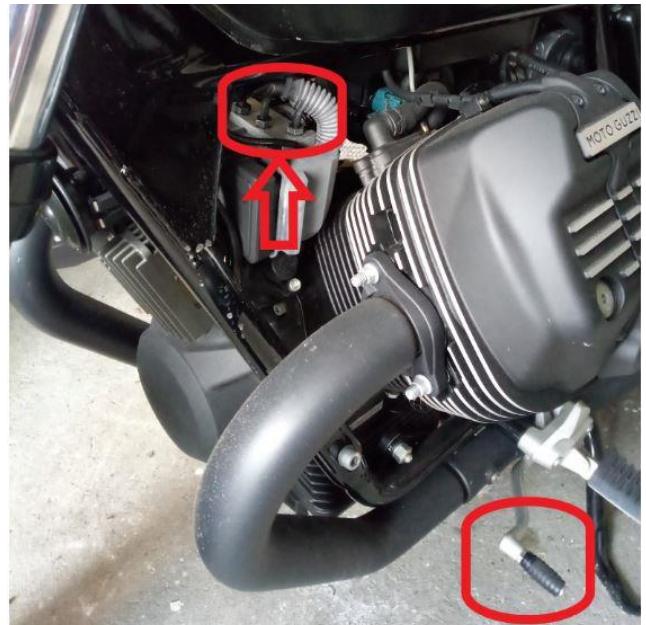
Position yourself on the left side of the vehicle (gear lever side) where the connection area of the ABS brake lines to the control unit is accessible. (see attached photo).

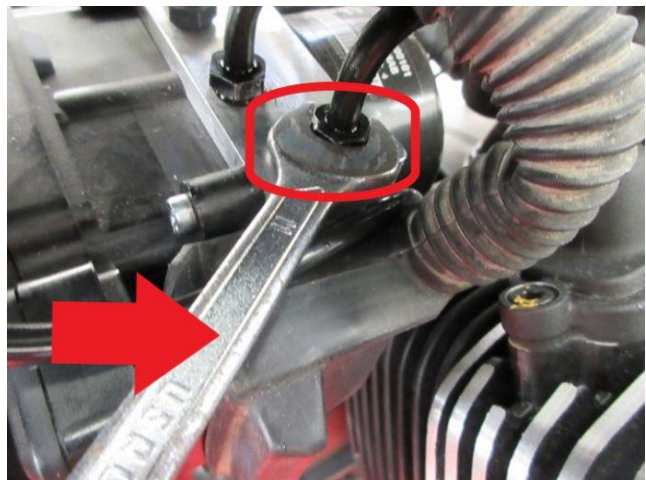
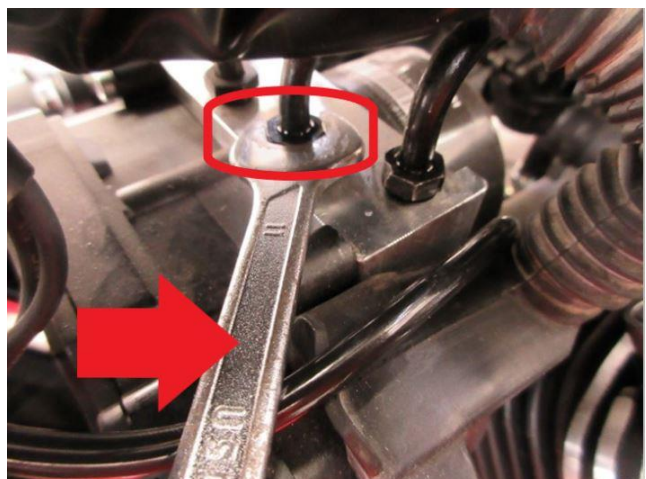
This technical update involves vehicles that have already installed the ABS lines support and is necessary in order to eliminate any tension due to the tightening of the lines themselves.

Loosen the two fixing nuts of the ABS brake lines on the control unit by turning them 90° anticlockwise. (see photo, loosening nut 1 connecting the brake line from the front brake lever to the ABS control unit and nut 2 connecting the brake line from the ABS control unit to the front brake calliper).
