Multistrada V4 Standard MY 2021 (all versions) Multistrada V4 S MY 2021 (all versions) Technical Service Bulletin SRV-TSB-21-004

Date: January 29, 2021

# CR205 – Multistrada V4 updates – 02/2021 Multistrada V4 Standard MY 2021 (all versions) Multistrada V4 S MY 2021 (all versions) Technical Service Bulletin SRV-TSB-21-004

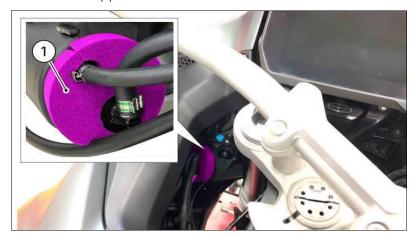
### Condition Corrective action Application of soundproofing pad part no. When the engine is idling and at 48612731A on the bottom of the canister filter operating temperature, a slight clinking noise may be heard coming from the canister filter located on the front left of the motorcycle. This is 1. due to the normal operating cycle of the filter and does not lead to any malfunction of the system. A pad is To be applied on all involved frame numbers applied to minimize this sound. Check and, if necessary, reverse the orientation When the side stand is down and the of the side stand return springs. No service part motorcycle is parked, engaging the is required for this portion of the procedure. first gear may cause the gearchange lever to get stuck under the side stand return springs. 2. Changing the orientation of the springs prevents this from happening and it will no longer be possible to engage the first gear after opening To be applied on all involved frame numbers the side stand. up to number #002470

**5.** Apply the **soundproofing pad (1)** on the bottom of the canister filter **rubber support (2)**, orienting it as shown in the figure.

During the operation, <u>DO NOT</u> touch the adhesive surfaces of the soundproofing pad with your fingers. Ensure to apply an even pressure on the external surface to make it adhere to the rubber support.
