# SERVICE BULLETIN

SEIVAIOE DO		_	
Classification:	Reference:	Date:	
DA18-033b	NTB18-076b	February 3, 2021

# 2018-2019 KICKS; REAR SONAR DOES NOT WORK WITH HEADLAMPS AND/OR PARKING LAMPS ON

**APPLIED VEHICLES:** 2018-2019 Kicks (P15)

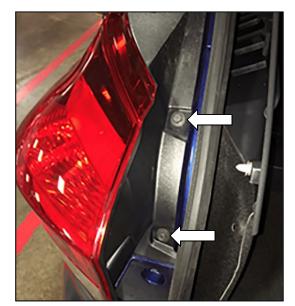
Figure 4

- 9. Remove the two (2) 10 mm bolts securing the driver side rear combination lamp (combination lamp).
- 10. Grab the combination lamp, and then carefully pull it off the vehicle body.
  - The combination lamp is fastened to the vehicle body by the 2 bolts and 2 push pins.

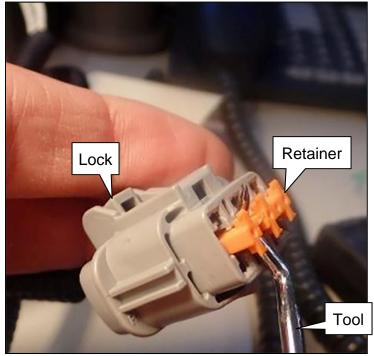
Figure 7

Remove the retainer by inserting a suitable pick in the notched hole and carefully prying out.

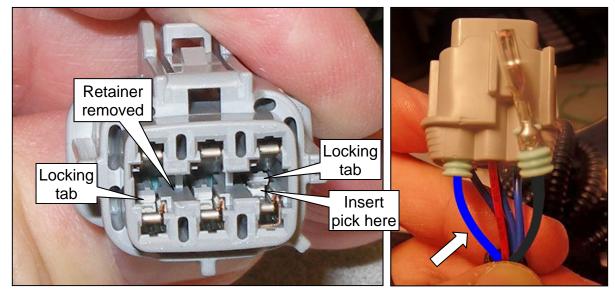
Figure 8 Figure 9

- 13. Remove the terminals of the **blue** and **black** wires from the combination lamp harness connector (see Figure 10 and 11 for selecting the correct **blue** wire).
  - Using a suitable pick, pry inward on the locking tabs, and then pull out the wires from the harness side of the connector. A flashlight may help see the tabs better.
  - The right side locking tab in Figure 8 is shown in the unlocked position.

**NOTE:** The color of the **blue** wire in Figure 9 is enhanced for easier viewing. Normally, it is the same shade of **blue** as the other **blue** wires.

- 14. Insert the **black** wire where the **blue** wire was positioned.
  - A slight audible click is heard when the terminal locks in place. Tug on the wire to make sure the terminal is locked in.
- 15. Insert the **blue** wire where the **black** wire was positioned.
  - A slight audible click is heard when the terminal locks in place. Tug on the wire to make sure the terminal is locked in.

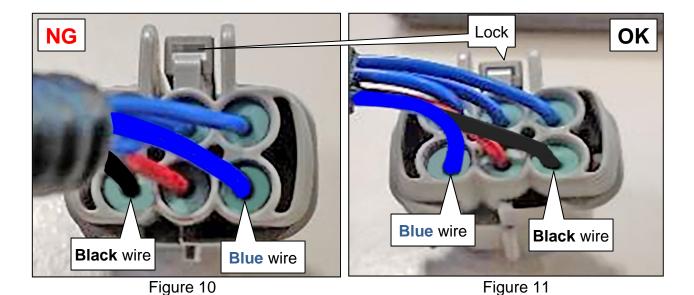
**NOTE:** The color of the **blue** wire in Figure 10 and Figure 11 is enhanced for easier viewing. Normally, it is the same shade of **blue** as the other **blue** wires.

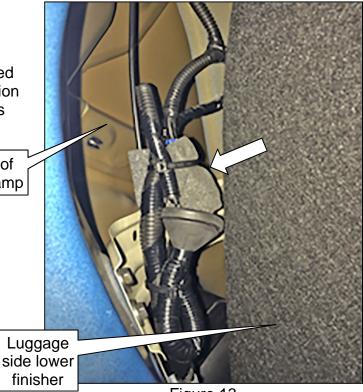
Figure 13

17. Locate the foam wrapped harness connector shown in Figure 13.

This connector will be rewrapped and fastened in the same position during assembly. Remember its position.

Area in front of combination lamp

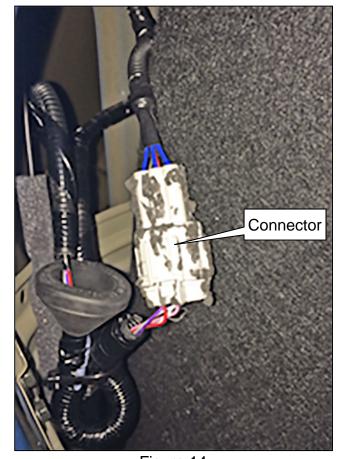
18. Using a suitable cutting tool, cut the "wire tie", and then peel off the foam from the connector.

**NOTE:** Figure 14 shows the connector with foam and "wire tie" removed.

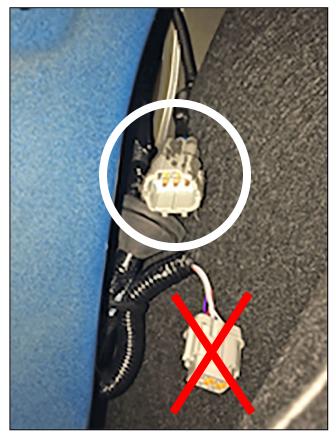
Figure 15

Perform repairs to the circled connector, not the one with the red "X" (see Figure 15).

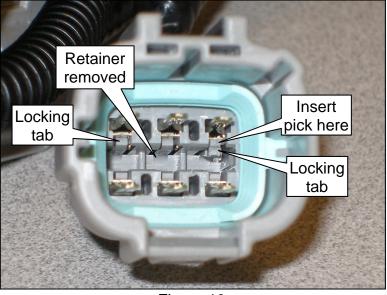
Figure 19 Figure 20

- 21. Remove both terminals of the **blue** and **black** wires from the connector (see Figure 21 and 22 for selecting the correct **blue** wire).
  - Using a suitable pick, pry inward on the locking tabs, and then pull out the wires from the harness side of the connector. A flashlight may help you see the tabs better.
  - The right side locking tab in Figure 19 is shown in the unlocked position.

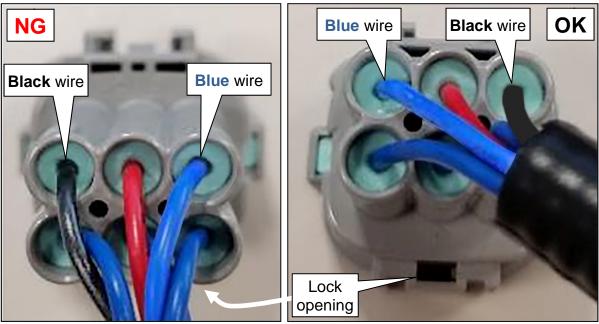
Figure 21 Figure 22

- 22. Insert the **black** wire where the **blue** wire was positioned.
  - A slight audible click is heard when the terminal locks in place. Tug on the wire to make sure the terminal is locked in.
- 23. Insert the **blue** wire where the **black** wire was positioned.
  - A slight audible click is heard when the terminal locks in place. Tug on the wire to make sure the terminal is locked in.

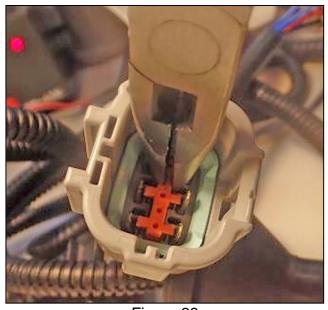
Figure 23

24. Insert the retainer using a suitable pair of needle nose pliers.

**CAUTION:** Make sure none of the pins are bent.
