CAMPAIGN BULLETIN

Tie Rod End Socket Nuts Dealer Inventory

Reference: PC795

PC795 – 2021 ALTIMA OUTER SOCKET (TIE ROD END) NUT

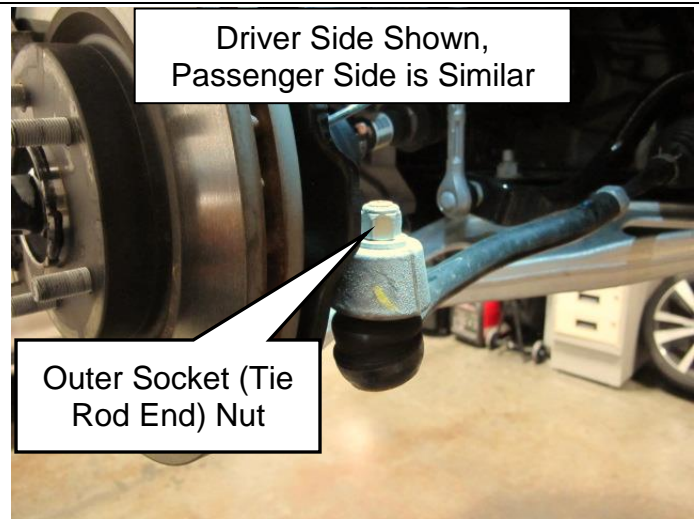
Figure 3

Nissan is conducting a dealer inventory quality action on **955** specific model year 2021 Altima vehicles identified in Service Comm to re-torque the front driver and passenger outer socket tie rod end nuts. Due to a manufacturing issue that has since been resolved, the subject vehicles may have socket nuts that are not torqued to specification.

3. Locate both front outer socket (tie rod end) nuts (Figure 3).
