CAMPAIGN BULLETIN

Engine Control Module (ECM) Reprogram Dealer Inventory

Reference: PM968
Date: February 2, 2021

PM968 – 2021 VERSA ECM REPROGRAMMING

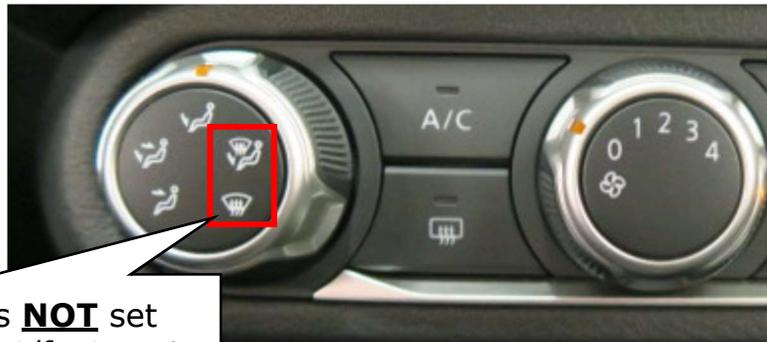
Figure 1

Make sure dial is **NOT** set to defrost or defrost/foot mode

1. Confirm the HVAC air flow control dial is **NOT** set to defrost or defrost/foot mode.

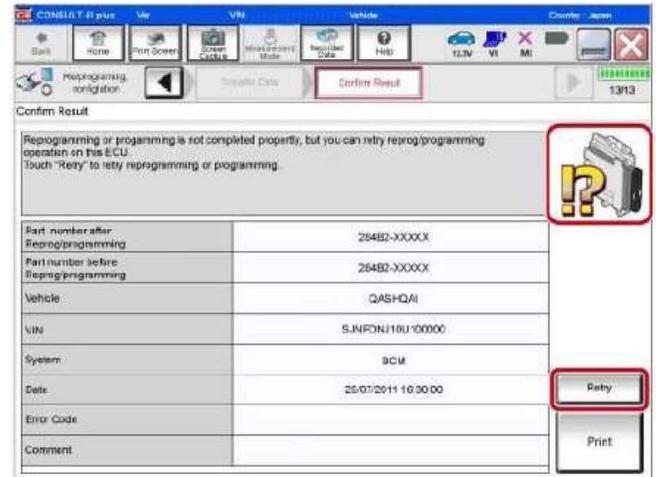
Figure 8

If reprogramming does not complete and the “!?” icon displays as shown in Figure 8:

- Check battery voltage (12.0–15.5 V)
- Ignition is ON, engine OFF
- External Bluetooth® devices are OFF
- All electrical loads are OFF
- **Select retry and follow the on screen instructions**
- “Retry” may not go through on first attempt and can be selected more than once

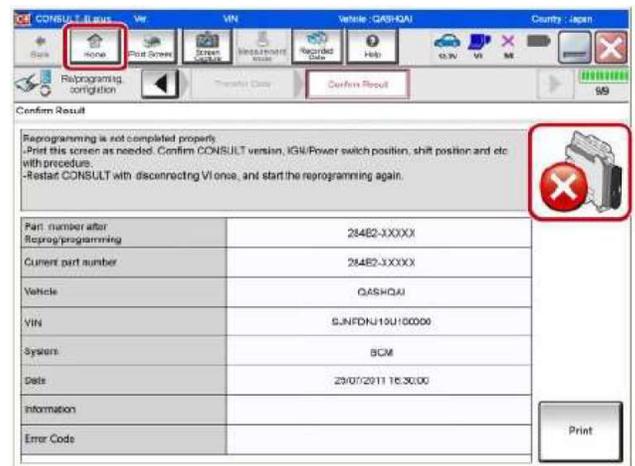
Figure 9

If reprogramming does not complete and the “X” icon displays as shown in Figure 9:

- Check battery voltage (12.0 – 15.5 V)
- CONSULT A/C adapter is plugged in
- Ignition is ON, engine OFF
- Transmission is in Park
- All C-III plus / VI cables are securely connected
- All C-III plus updates are installed
- **Select Home, and restart the reprogram procedure from the beginning**
