SERVICE BULLETIN

Classification: AN21-001	Reference: NTB21-011	Date: February 17, 2021
-----------------------------	-------------------------	----------------------------

2020-2021 TITAN AND TITAN XD; FALSE MAINTENANCE ALERT NOTIFICATION

APPLIED VEHICLES: 2020-2021 Titan/Titan XD (A61) – SV w/Convenience Package, SL, Platinum Reserve, PRO-4X

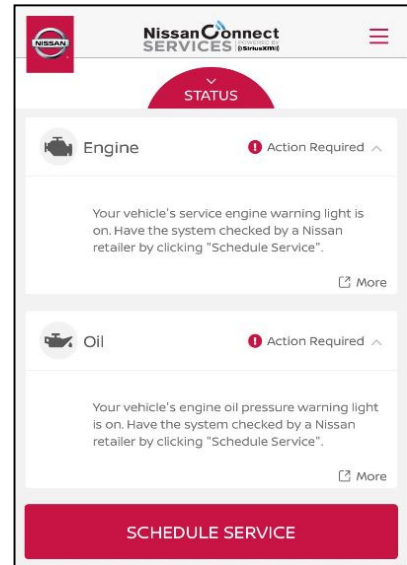
Figure 1

The customer receives a Maintenance Alert from NissanConnect Services notifying them that the oil pressure warning light is on or that the service engine warning light is on,

there are no warning lights ON in the instrument panel,

there are no related DTCs stored.

Update the TCU to the latest software version.
