Service Bulletin

Bulletin No.: 21-NA-018

Subject: Pop Noise Heard Coming from Rear Roof of Cab Area

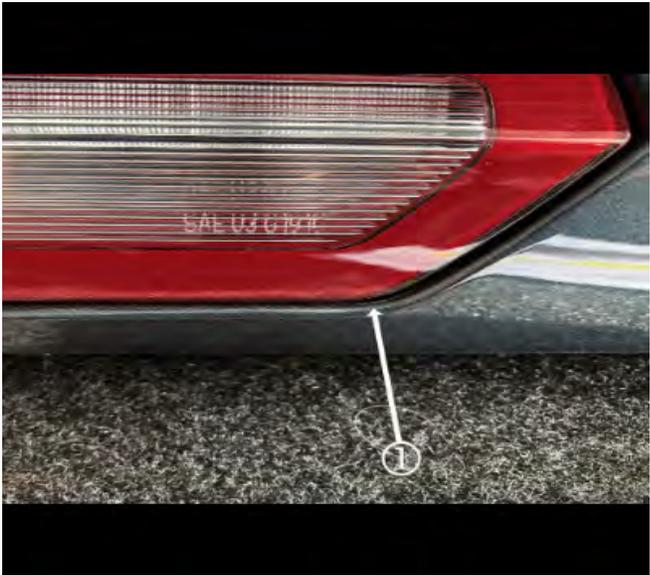
5720095

Note: In the graphic examples above, a gap (1) can be noted on the passenger side lower corner of CHMSL. In the second example a slight wear mark (2) in the spoiler paint can be seen.

The cause of the condition may be an Interference between the Center High Mount Stop Lamp (CHMSL) and the body of the spoiler. As these parts expand and contract, with the changes in ambient conditions, there is a stick-slip condition that generates noise.

Following the steps in the Service Procedure below, apply foam tape between the CHMSL and the spoiler body, to create space between the CHMSL and spoiler.
