TITLE:  
**Squeaking noise under front seats cushions**

<b>REF NO:</b> TJ 35817.1.0	<b>ISSUING DEPARTMENT:</b> Technical Service	<b>CAR MARKET:</b> United States and Canada	
<b>PARTNER:</b> 3 US 7510 Volvo Car USA		<b>ISSUE DATE:</b> 2020-12-22	<b>STATUS DATE:</b> 2021-01-11
<b>FUNC GROUP:</b> 8526	<b>FUNC DESC:</b> Adjustment device, assembly parts	Page 1 of 3

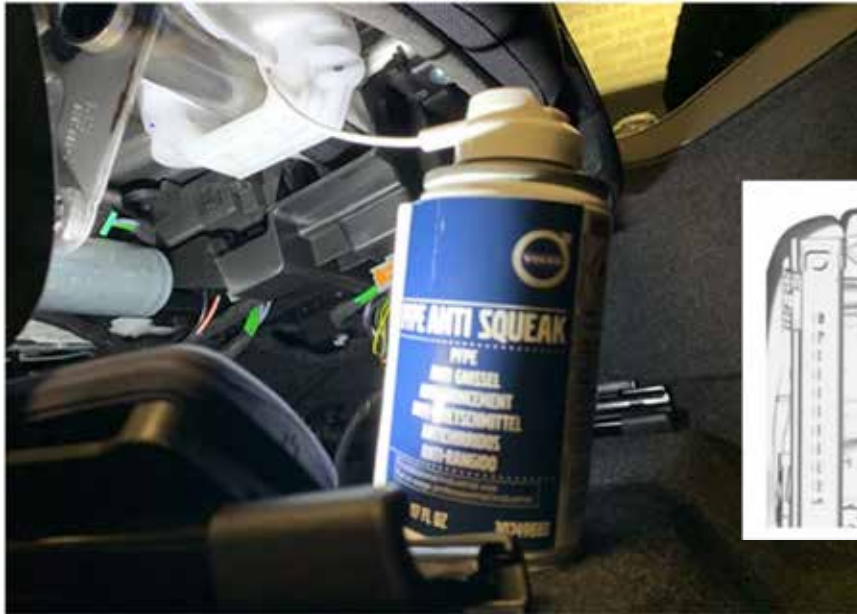
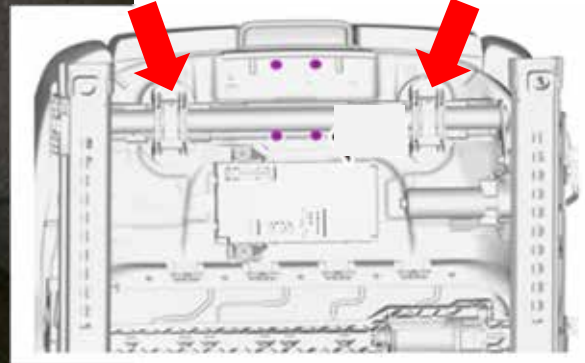
TJ 35817

If squeaking noise can be heard from the underside of a front seat cushion, see Service.

Apply PTFE-spray as shown on picture “TJ 35817.pdf” (2 plastic holders on each front seat).  
Raise the seat to the highest and apply from front.

Use PFTE-spray p/n 30749880.
