Technical Journal

Window guide moulding front doors, deformed

REF NO: TJ 35789.1.0	ISSUING DEPARTMENT: Technical Service	CAR MARKET: United States and Canada	
PARTNER: 3 US 7510 Volvo Car USA		ISSUE DATE: 2021-01-05	STATUS DATE: 2021-01-11
FUNC GROUP: 8455	FUNC DESC: Guide moulding for door glass; sealing	Page 1 of 3

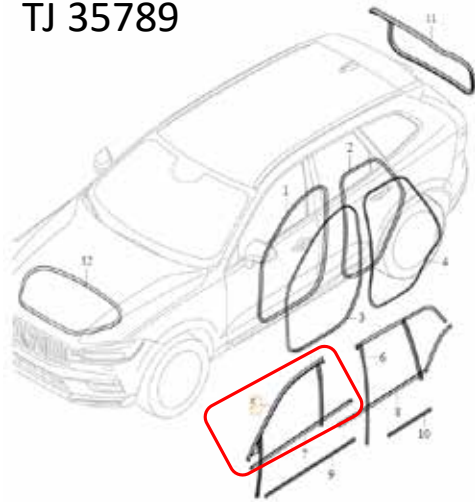
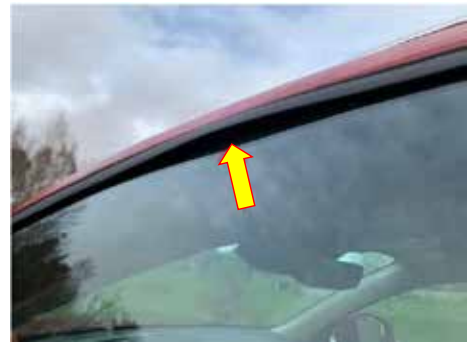
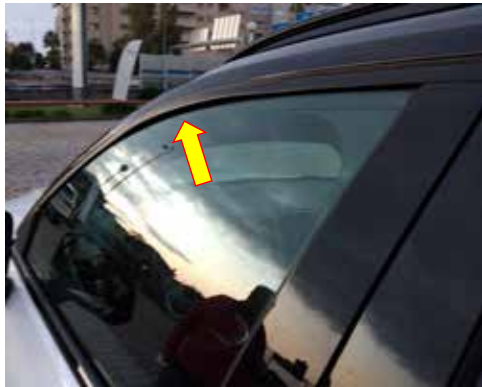
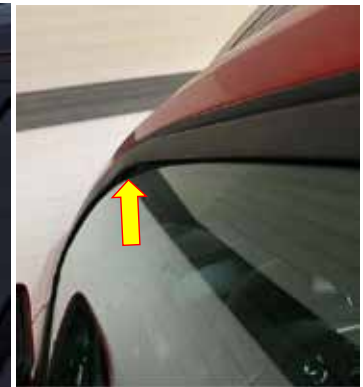
TJ 35789

If vehicle shows symptom of front doors window guide moulding not being in correct position by having uneven appearance, follow the instructions under “Service”. Attached you will find some pictures of incorrect position/appearance.

Open the window. Press the incorrect part of the guide moulding inwards/towards the car until it is attached to the door bow. If needed, repeat the operation along the part, starting in the middle, until it is all in correct position.
