# Technical Journal

**Remote Control Key No function**

<b>REF NO:</b> TJ 33031.5.0	<b>ISSUING DEPARTMENT:</b> Technical Service	<b>CAR MARKET:</b> United States and Canada	
<b>PARTNER:</b> 3 US 7510 Volvo Car USA		<b>ISSUE DATE:</b> 2021-01-14	<b>STATUS DATE:</b> 2021-01-25
<b>FUNC GROUP:</b> 3666	<b>FUNC DESC:</b> Access (central looking & remote)	Page 1 of 5

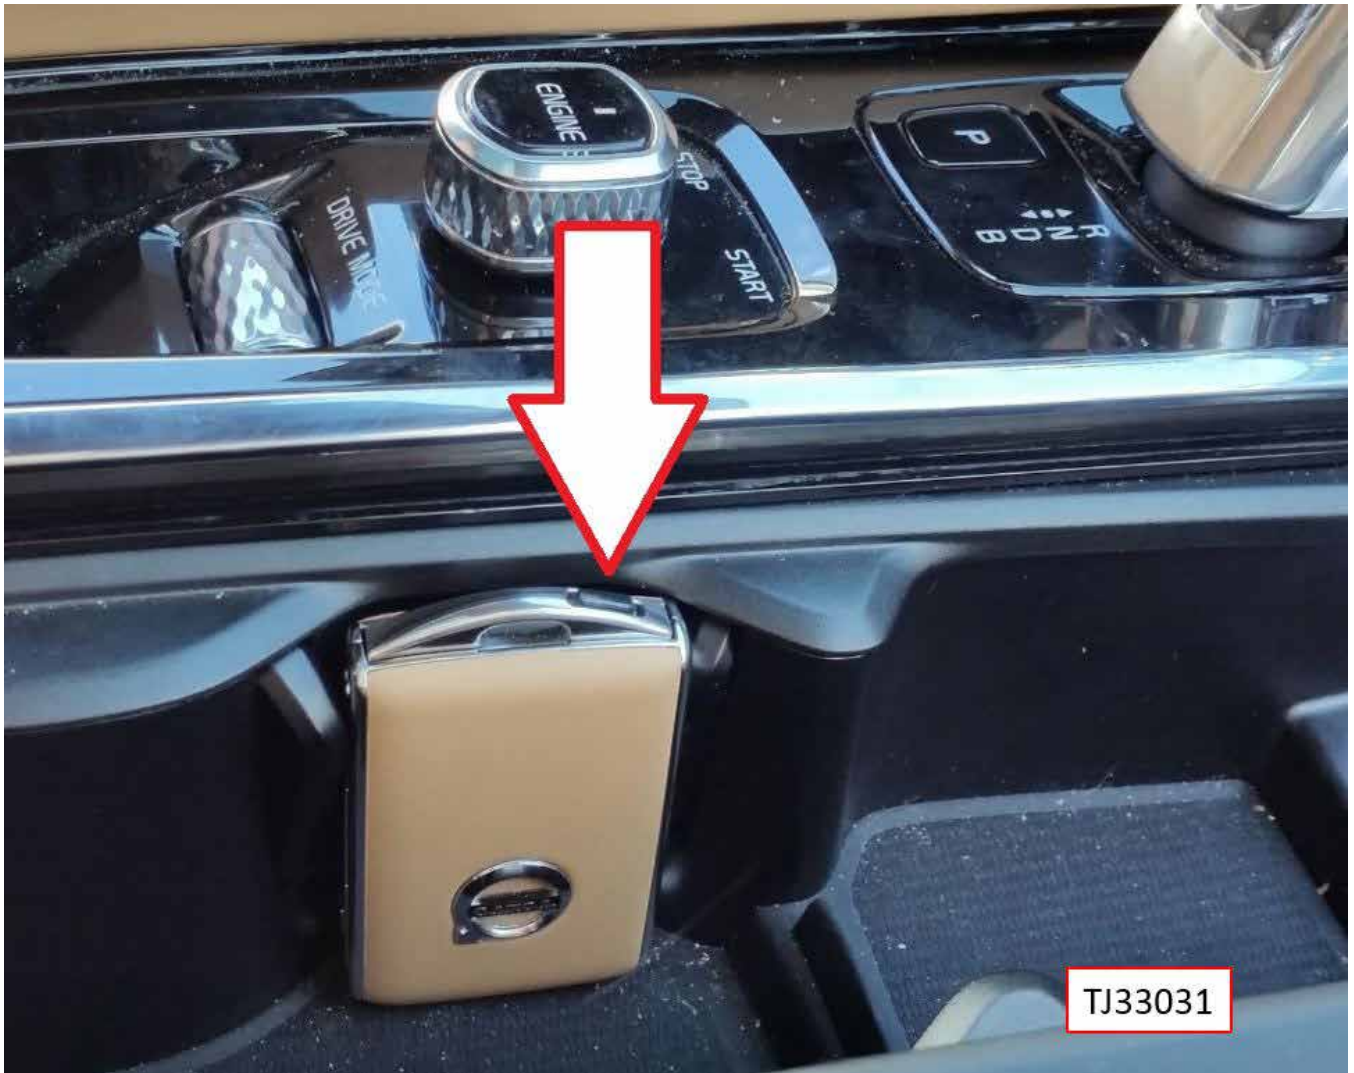
File Name	File Size
TJ33031.JPG	0.1052 MB

If remote control key lock/unlock and/or keyless functions are not working but the car **is** detecting the remote control key while placed in the cup holder next to the antenna (see attached \*picture”TJ33031.jpg”), please **measure voltage** of the battery in the remote control key, if the battery is not OK exchange battery: **2.7-3.3 volts is considered OK.**

If remote control key lock/unlock and/or keyless functions are not working and the remote control key **is NOT** detected while placed in the cup holder next to the antenna (see attached picture”TJ33031.jpg”), please erase all concerned remote control keys and reprogram them to the car by downloading the “Keyless Key application” with VIDA.
