Classification:
AN19-067d

Reference:
ITB19-041d

2020 Q50; BOTH CENTER DISPLAY SCREENS ARE BLANK

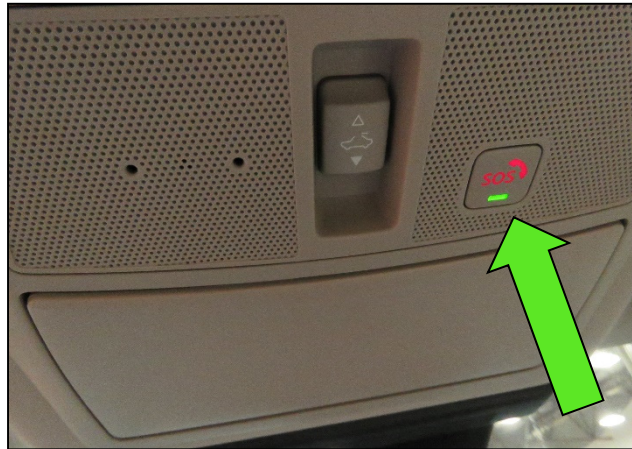
Figure 1

APPLIED VEHICLE: 2020 Q50 (V37)
APPLIED SYSTEM: Vehicles equipped with factory navigation system (Vehicles equipped with navigation will have an SOS button in the overhead console assembly).
