SERVICE BULLETIN

Classification: AN19-069b	Reference: NTB20-002b	Date: February 4, 2021
------------------------------	--------------------------	---------------------------

2019 SENTRA; STEERING WHEEL AUDIO SWITCHES INTERMITTENTLY INOPERATIVE

APPLIED VEHICLE: 2019 Sentra (B17) – S model only
APPLIED VIN: Vehicles Built before 3N1(*)B7AP(*)K(*)432870
APPLIED DATE: Vehicles Built before October 10, 2019

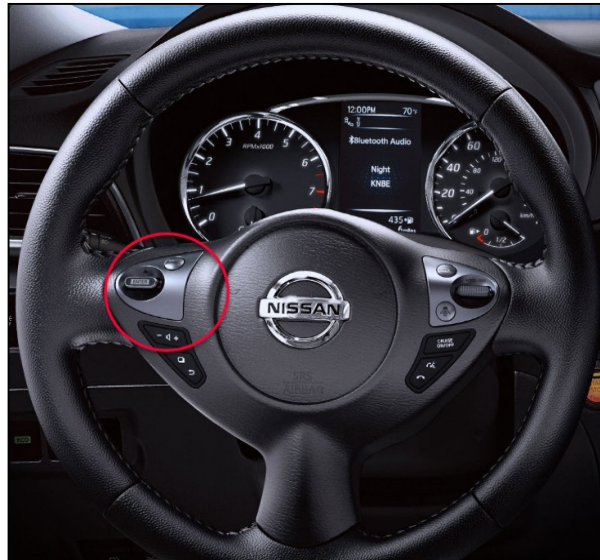
Figure 1

The steering wheel audio switches (Figure 1) are intermittently inoperative.

Update the AV control unit software. Refer to **SERVICE PROCEDURE** on page 2.

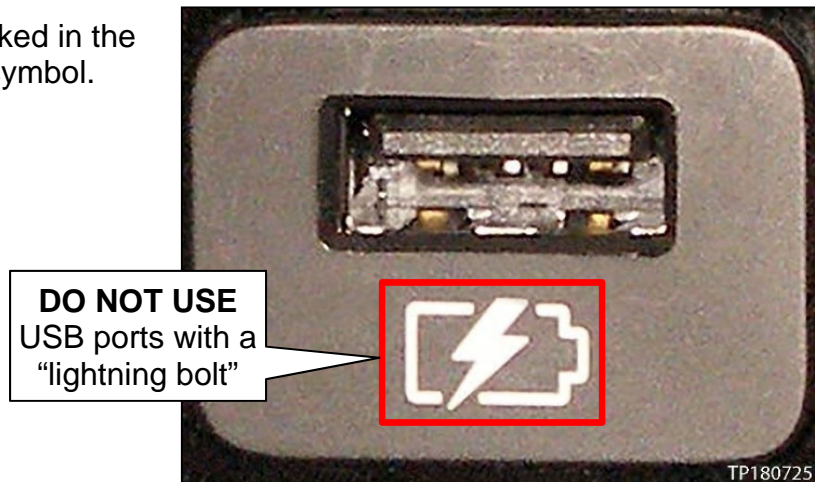
Figure 13

Do not insert the USB drive into a charging port (Figure 13). If used, the update software and/or USB drive may become damaged. Only insert the USB drive in a USB media port.
