SERVICE BULLETIN

Classification: AN20-001a	Reference: NTB20-006a	Date: February 4, 2021
------------------------------	--------------------------	---------------------------

2018-2020 ARMADA; INFOTAINMENT ERROR MESSAGE "UNABLE TO CONNECT TO THE CENTER" DISPLAYED

APPLIED VEHICLES: 2018-2020 Armada (Y62)

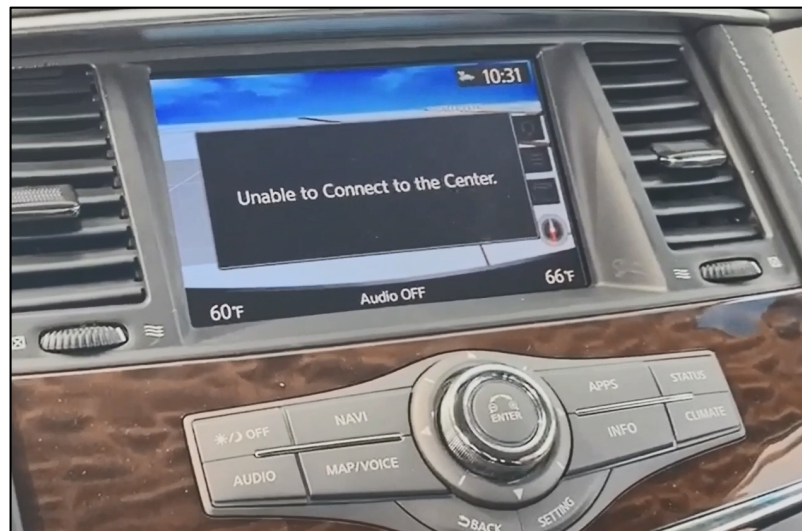
Figure 1

- The error message “Unable to Connect to the Center” is displayed on the infotainment screen (see Figure 1),

1. Identify the TCU ID.
2. Manually configure the display control unit.
