AN18-024d

ITB18-041d

2019 QX50; AUDIO SYSTEM WILL NOT TURN ON AND/OR SCREENS FREEZE UP AFTER HANGING UP A PHONE CALL

APPLIED VEHICLE: 2019 QX50 (J55)

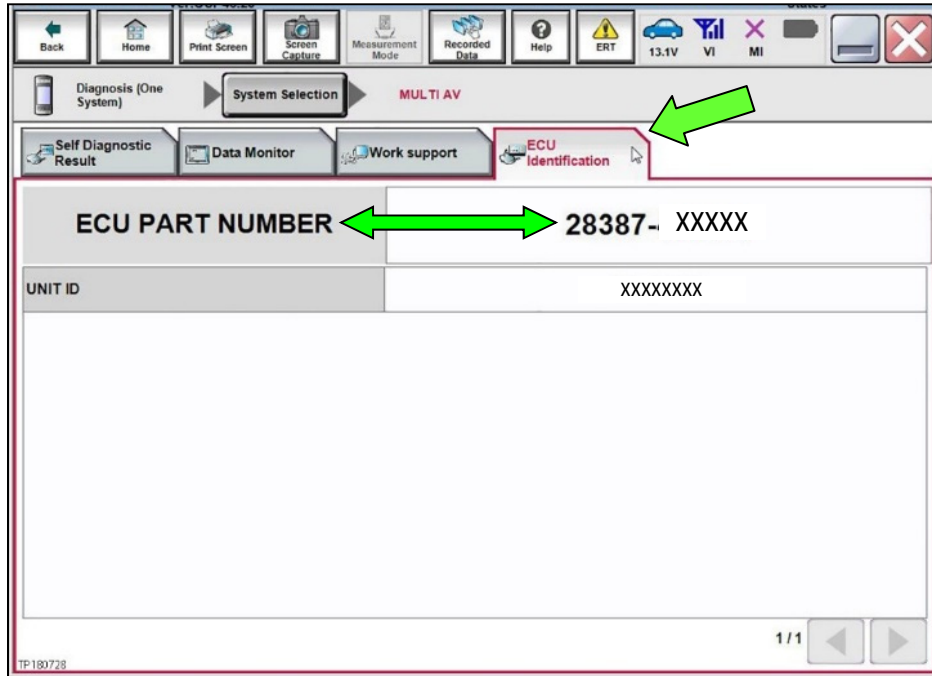
7. Select the **ECU Identification** tab.
8. When the screen in Figure 4 displays, confirm this bulletin applies as follows:
 - a. Write down the **ECU PART NUMBER** on the repair order.

- b. Compare the P/N written down to the P/Ns in the **CURRENT DCU PART NUMBER** column in **Table A** below.
 - If there is a match, proceed to step 9 on the next page.
 - If there is not a match, DCU updating does not apply. Refer to ASIST for further diagnosis.

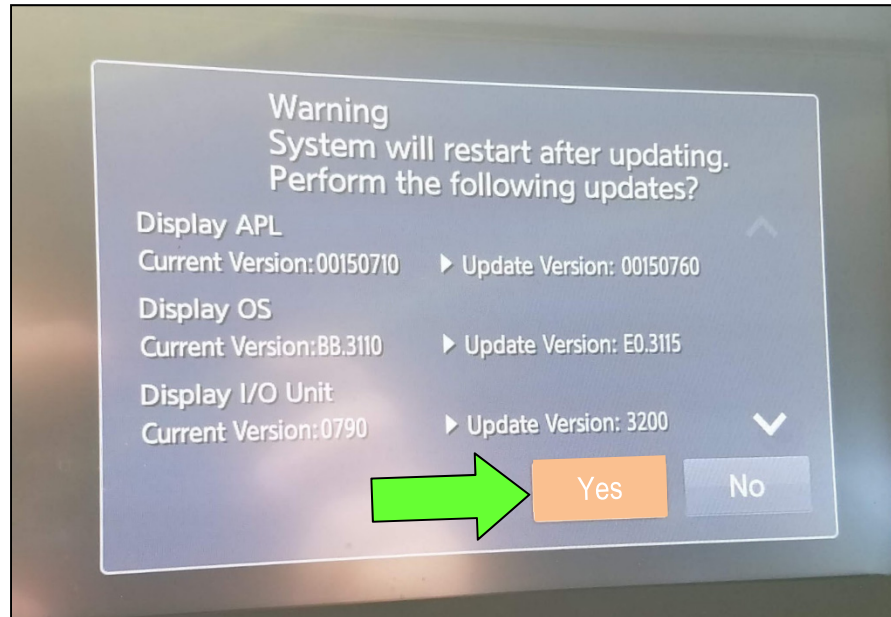
25. Wait approximately 10-30 seconds for the screen in Figure 19 or Figure 20 to appear.
- If the screen shown in Figure 19 appears, proceed to step 26 below.
 - If the screen shown in Figure 20 appears, then no software update is available. Refer to ASIST for further diagnostic information.

26. Select **Yes** to begin the software update.
