SERVICE BULLETIN

Classification: AN18-014a	Reference: NTB18-034a	Date: February 10, 2021
------------------------------	--------------------------	----------------------------

2017-2018 SENTRA WITH NON-NAVI SYSTEM; AUDIO PRESET BUTTONS STICK DOWN OR SLOW MOVING

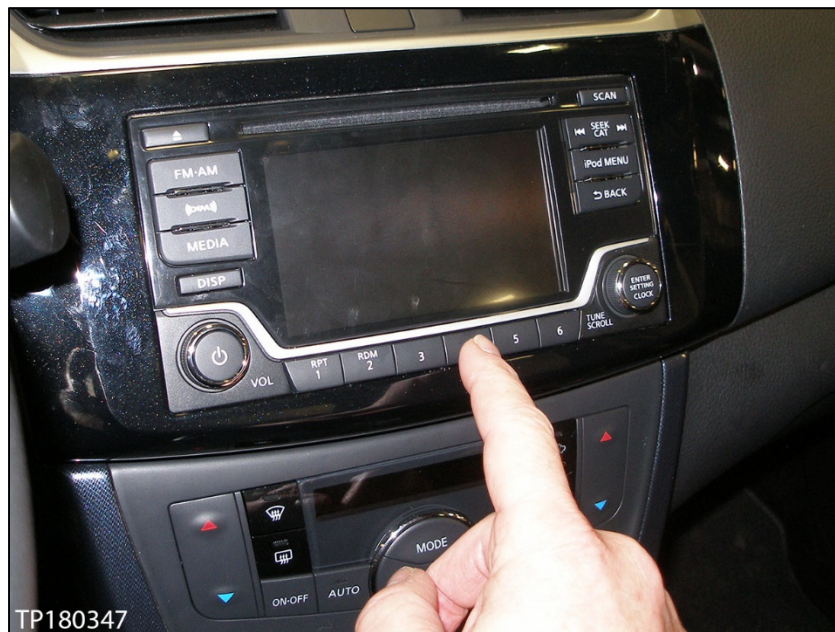
Figure 1

One or more of the audio preset buttons of an applied vehicle sticks down (does not pop up after pushing down) or is slow to move back to its rest position after pushing down.

Reposition, or replace as necessary, the felt tape on the cluster lid C.
