94-19-01 - Exterior Lights, Moisture Accumulation

Release date: 3/2/2021

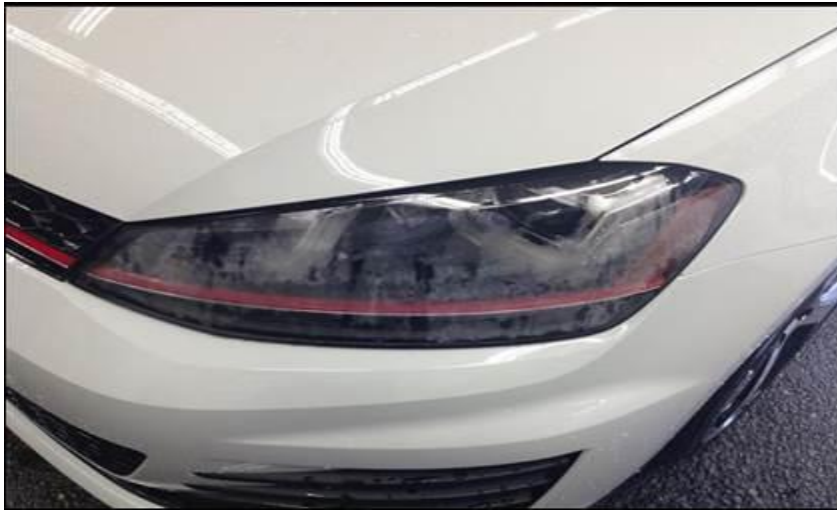
Figure 1

Exterior light assemblies (headlights, taillights with incandescent bulbs, fog lights, turn signals) are vented and may collect moisture on their inner surfaces, depending on humidity and climatic conditions. The unfavorable condensation built up (Figure 1) visible to the customer is more common with modern exterior lights because of clear glass optics, however this condition will not have an impact on the functionality or durability of the component.

For headlight condensation that is due to environmental conditions, the affected lens surface should be cleared after approx. 30 minutes of light operation.

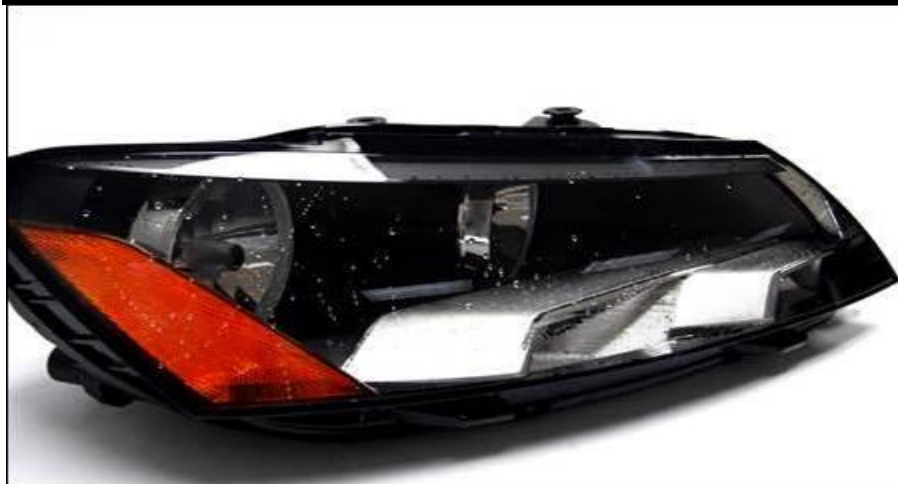
Figure 2

In cases where larger water droplets have formed on the inside of the lens or significant amount of water has collected at the bottom of a light assembly, Figure 2:

- Check for leaking seals, cracks in lenses or assemblies.

DO NOT replace light or lens assemblies unless damage is found.
