Technical Service Bulletin

10 Oil is lost from the filler cap

10 21 21 2059446/4 March 8, 2021. Supersedes Technical Service Bulletin Group 10 number 20-20 dated October 29, 2020 for reasons listed below.

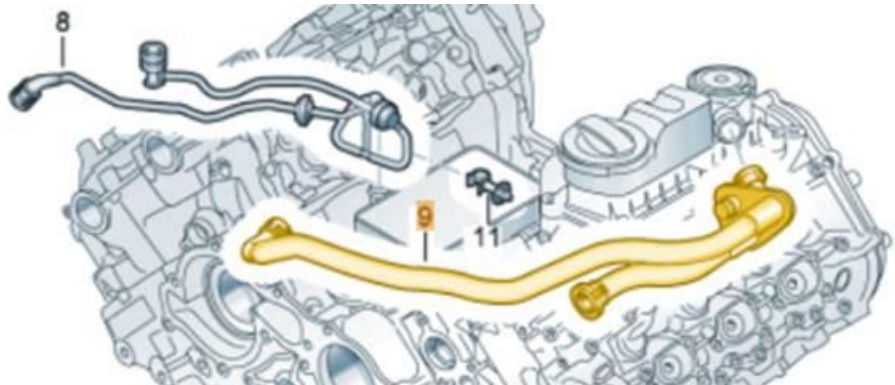
A faulty membrane in the breather line can result in excess pressure in the crankcase and therefore some oil is lost through the filler cap.

Figure 1. Breather line for the Turbocharged V6.

Replace the breather line (different variants available, only order by VIN) by following the Elsa repair manual (Figures 1 and 2).

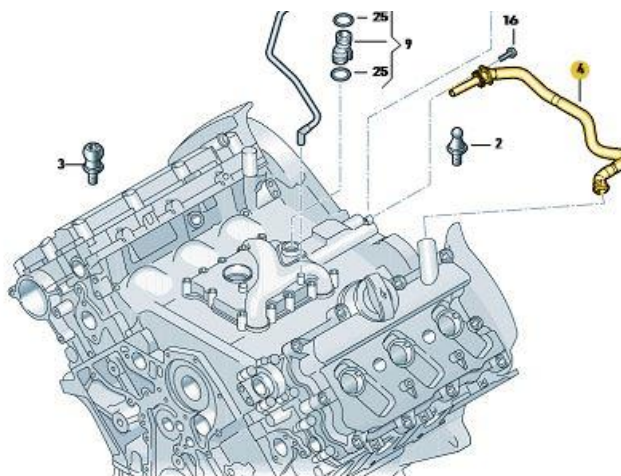
Figure 2. Breather line for the Supercharged V6 (EVO).
