Technical Service Bulletin

90 Drive select menu is greyed out in the MMI, DTC U111000 is stored in the information electronics control module

90 21 94 2061989/2 March 4, 2021. Supersedes Technical Service Bulletin Group 90 number 21-86 dated January 28, 2021 for reasons listed below.

Model(s)	Year	VIN Range	Vehicle-Specific Equipment
Q5, SQ5	2021	All	Not Applicable

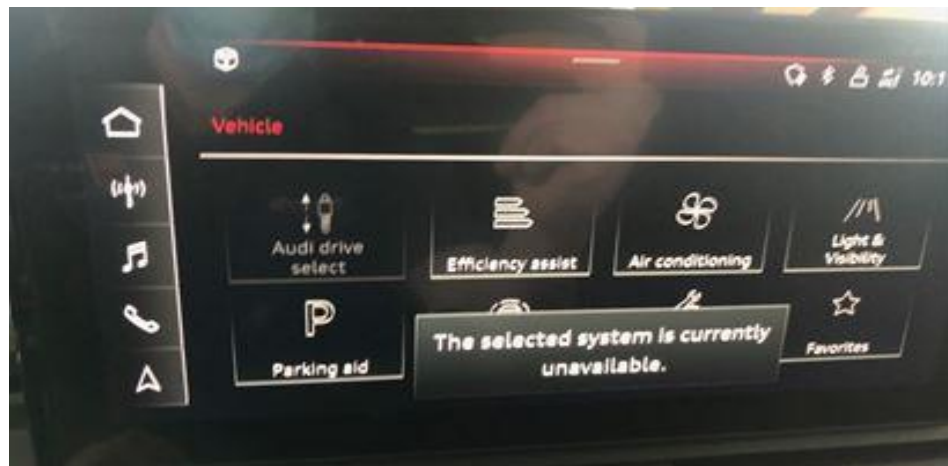
- The drive select menu is greyed out in the MMI and the message "The selected system is currently unavailable" appears (Figure 1).

Figure 1. Drive select is unavailable.

The following DTC is stored as static in the information electronics 1, J794 (address word 005F)

- DTC U111000** (Function restriction due to communication interruption) with symptom code 7191.

If the above condition and DTC are present, perform the replacement test plan for the Gateway, J533 (address word 0019) as follows:

1. At the first prompt, use selection
2 – New control module (Figure 2).

2. At the second prompt, use selection 1 – No SVM code (Figure 3).
- Check whether your ordering system/parts catalog (e.g. ETKA, special note, ...) or one of the available Technical Service Bulletins (TSB) indicates a SVM code (e.g. XCHG...).

3. Follow the on screen prompts.
4. Once complete allow a 10 minute sleep cycle and re-check the operation. Drive select functions are now restored and the DTC can be cleared.
