# Technical Service Bulletin

## 91 No diagnostics communication to the telematics control module

91 21 77 2056076/11 March 2, 2021. Supersedes Technical Service Bulletin Group 91 number 20-29 dated November 9, 2020 for reasons listed below.

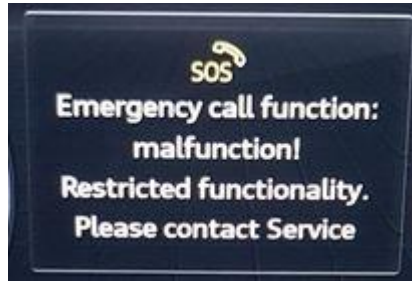
- An SOS Warning might be displayed in the instrument cluster (Figure 1).

**Figure 1.** Emergency call malfunction warning.

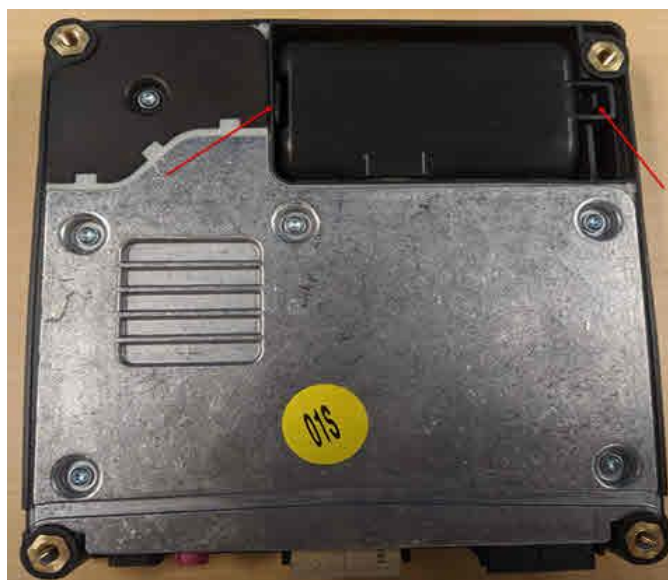
**Figure 2.** Backup battery compartment location.

1. Remove and unplug the telematics control module, J949 (address word 0075) according to the repair manual in Elsa.
2. Open the battery compartment of the telematics control module, J949 (address word 0075) and disconnect the backup battery (Figures 2 - 3).

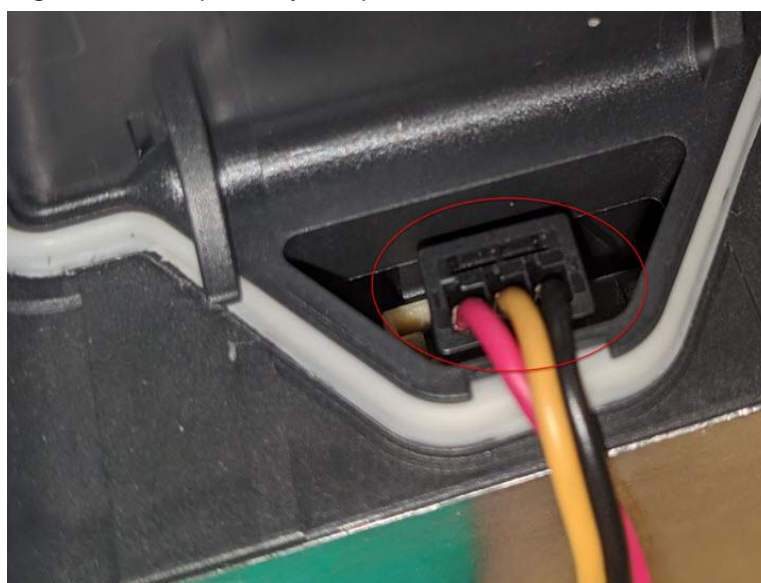
**Figure 3.** Backup battery connector (no release mechanism).
