## ContiLifeCycle Technical Service Bulletin

### Tech Tip Adhesion

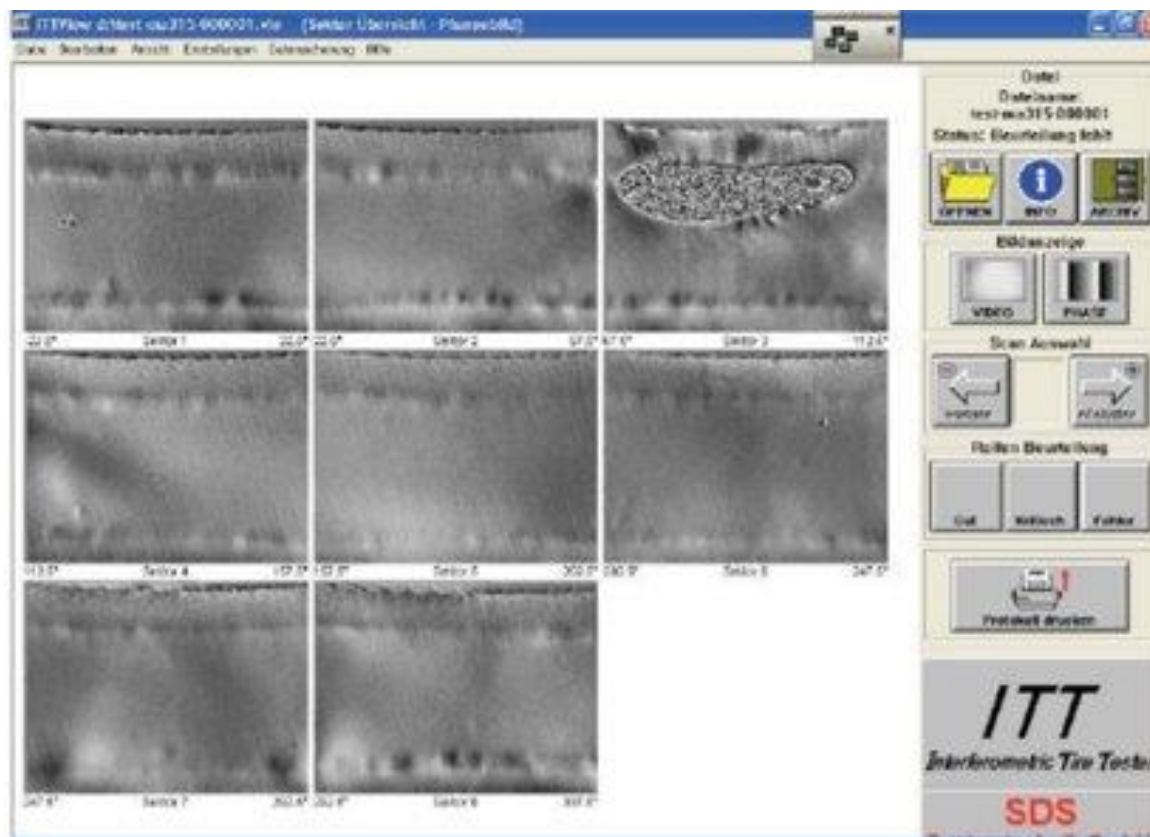
**Recently, treads manufactured in our Mount Vernon, Illinois facility were observed to have an extremely low occurrence of no buff texture, which has led to a low occurrence of tread detachment issues. The issue was corrected in our manufacturing facility on January 29<sup>th</sup>, 2021 however, for any tread manufactured prior to that date, the following actions must be taken:**

### Example of “No Buff Texture” Shearography Finding:

- › If Shearography is available, after curing, and after the tire has cooled, run the tire through Shearography and look for any signs of a lack of adhesion, such as the example shown here.
- › If there is a question regarding the Shearography findings, **hold tire** for warranty processing.
