STAR ONLINE PUBLICATION

Case Number: S1708000055 – Rev. A

Symptom/Vehicle Issue: Overcharging/Undercharging DTC's Interior And Exterior Lamps Flicker, Electronic Stop/Start (ESS) Operates Intermittently, Crank No Start, Vehicle Will Not Restart After ESS Stop

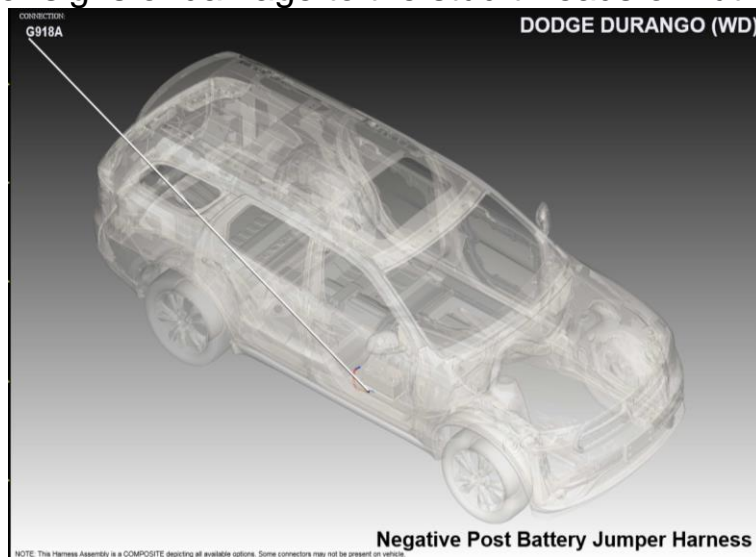
Diagnosis: Overcharging/Under charging DTC's exist. The interior and exterior lamps flicker. Electronic Start/Stop (ESS) does not work. Customer may notice a message on the dash display stating "Stop/Start Not Ready Battery Charging". The engine may start only two or three times. After that, when trying to start, the engine may crank once, but will not start.

Repair Procedure: Check for a possible loose ground terminal at the G918A ground location in the battery compartment under the passenger seat. If the ground nut is found loose, check for signs of damage to the stud threads or nut. Repair as needed.
