STAR ONLINE PUBLICATION

Case Number: S2123000009

Symptom/Vehicle Issue: Water is leaking into cab through the third brake light CHMSL

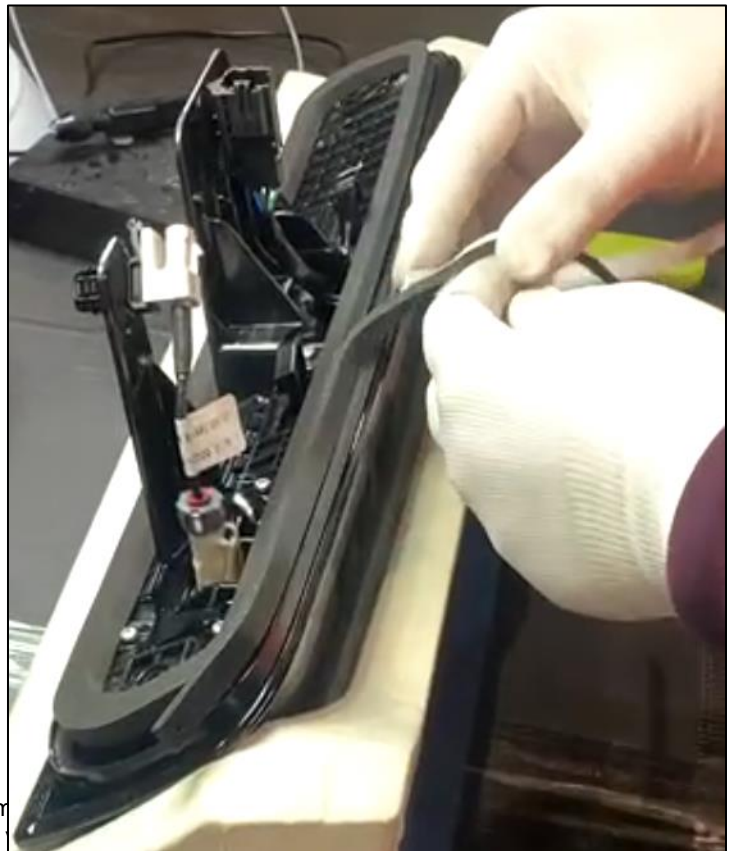
Customer Complaint/Technician Observation: Customer complains of water on the headliner / water at the back of the cab and technician observes a leak from the third brake light / CHMSL.

Order a replacement LED CHMSL (Part Number 68444540AB) and order a secondary gasket (Part Number 68545973AA).

Apply the secondary gasket directly onto the main gasket of the CHMSL. The secondary gasket should be at the top of the part when installed. Remove the adhesive backing from the secondary gasket as you go. You may want to use a ruler or credit card to lightly press the secondary gasket onto the main gasket.
