STAR ONLINE PUBLICATION

Case Number: S2008000190 – REV. A

Symptom/Vehicle Issue: User Is Unable To Create A New Profile In The R1H Radio Uconnect 5

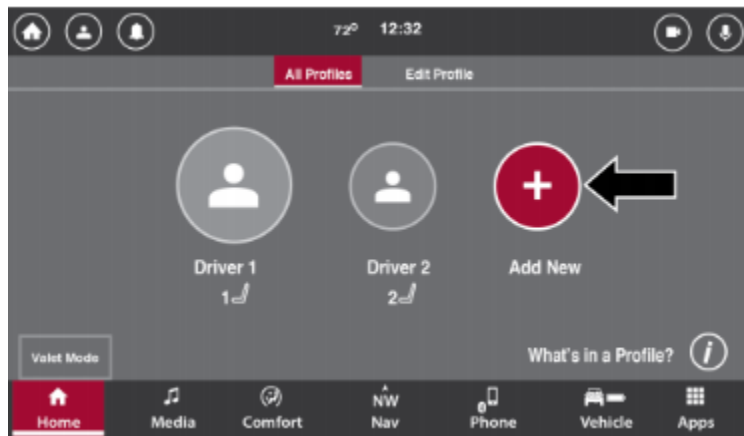
Fig 1 Add New Profile.

Discussion: User is unable to create a new profile in the R1H Radio. Soft keys are not visible on the radio to add a new profile. This feature is **Not** available on early built vehicles.

Do Not Replace The Radio (ETM), TBM, or Display for this concern. This feature is not available on early built vehicles. The feature will be activated by an over-the-air update tentatively in late 1st quarter 2021.
