## STAR ONLINE PUBLICATION

**Case Number:** S2108000054

**Symptom/Vehicle Issue:** Power Driver Window Auto Up And Down Feature Does Not Operate

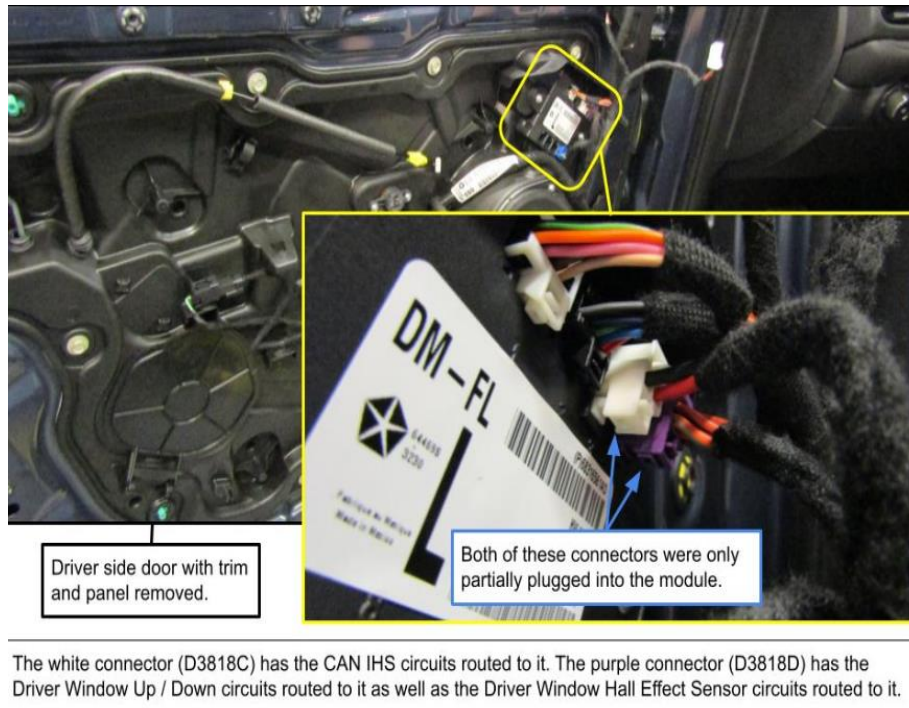
**Customer Complaint/Technician Observation:** Owner complains the driver side power window switch has to be depressed multiple times to close and or open the window (window moves ¼ distance each apply). Technician observed the window operation as described and located a DTC B25B0-31 - Window Position Sensor - No Signal

**Discussion:** Remove the driver door panel and inspect and secure connectors at the door module and the driver window motor. Partially engaged connectors can contribute to this condition. Secure all connections, calibrate the window per service information pg 2 and test the operation, no added parts required.
