## STAR ONLINE PUBLICATION

**Case Number:** S2123000012

**Symptom/Vehicle Issue:** Squeak Noise From Exterior Door Handle

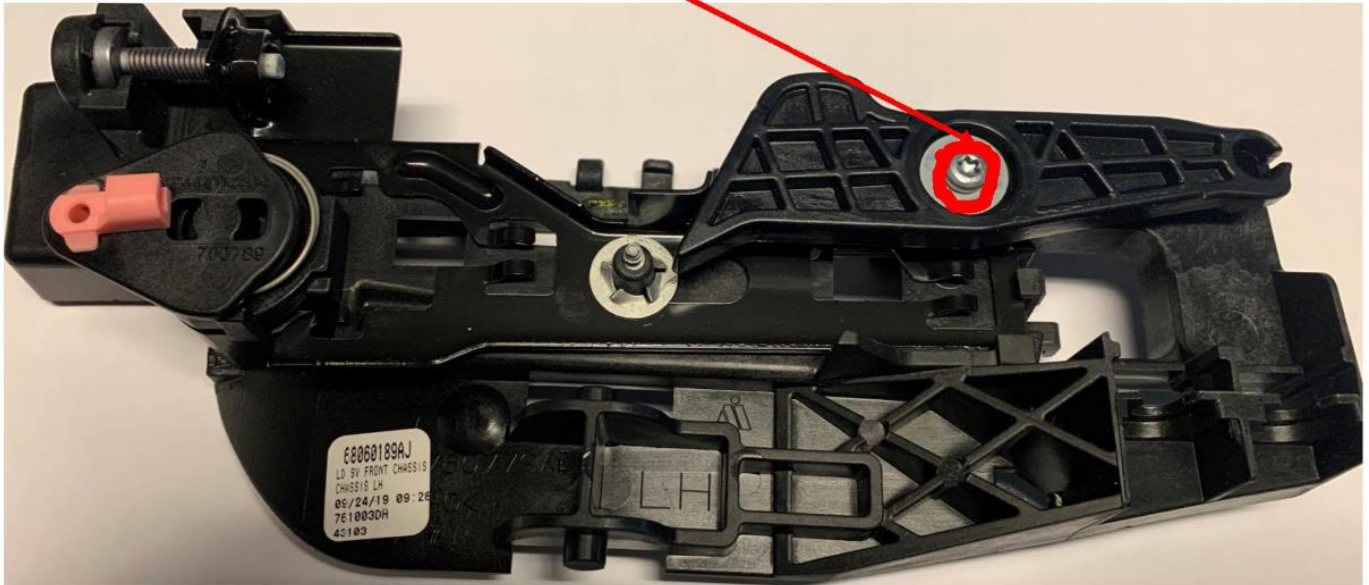
Lifting the door handle causes a squeak noise.

Follow the Service Library handle removal procedure- 23 - Body / Doors - Front or Rear HANDLE, Exterior / Removal. Apply Mopar grease 05083150AA to the bell crank screw/washer (Fig 1). Optional lubricant is Mopar 05019059AC. Work the grease into the screw area by lifting handle several times while handle is off the car. Reinstall the handle(s) following 23 - Body / Doors – Front or Rear / HANDLE, Exterior / Installation.

Apply MOPAR grease 05083150AA or 05019059AC to screw washer
