Jeep

Case Number: S1408000259 Rev A

Radio Display Screen Goes Blank During ABS Activation, HVAC Controls And Blind Spot System Operate Intermittently, Cluster Warning Chime Goes Off

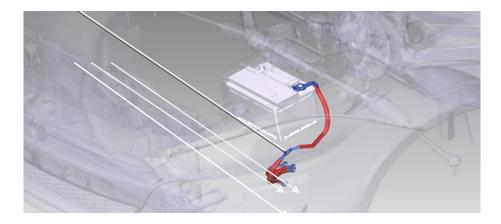
Fig 1

If the above DTC's and condition are present review <u>ALL</u> grounds. Perform voltage drop tests as required to help diagnosis. A reading of more than .5v should be investigated. Test all the component ground location attachments looking for corrosion, loose connection, thread damage ect. Figures below show several ground locations.
