NUMBER: 23-007-21

Split/Crack of Metal Body Side Door Check Strap

2014 - 2020

RAM ProMaster

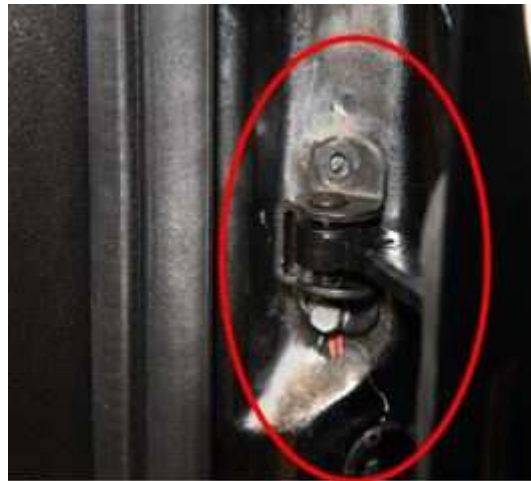
The customer may notice a metal split or crack on the body side on either the driver or passenger side of the door check strap area (Fig. 1).

Fig. 1
Check Strap Area Cracking

This bulletin involves retrofitting the door check strap mounting on the body side.

****A step by step service repair is available. Refer to the detailed service procedures available in DealerConnect> Service Library>Collision Info under: 31 - Collision Information / Standard Procedure> Hinge Pillar Repair.****
