**NUMBER:** 18-012-21

**DATE:** February 5, 2021

Flash: Powertrain Control Module (PCM) Updates

2020	(DJ)	RAM 2500 Pickup
2020	(D2)	RAM 3500 Pickup

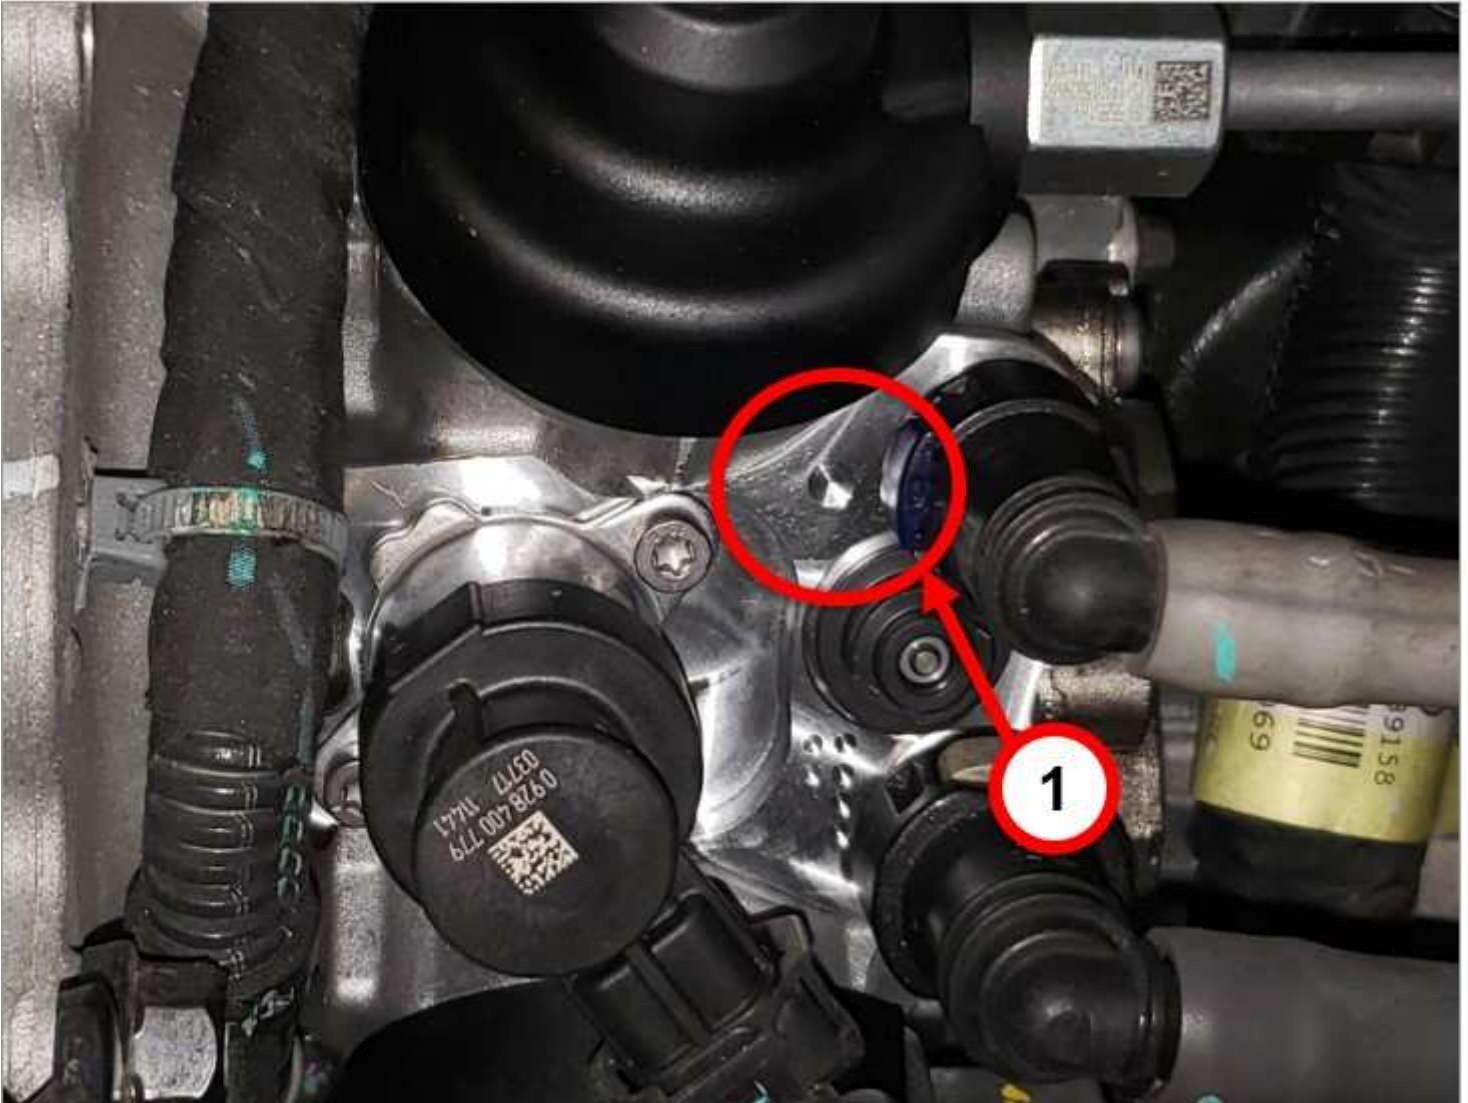
**Fig. 1**  
**New Style Symmetrical Cam Design Pump**

**NOTE: You may be presented with two calibration choices when flashing the ECM. Please follow the inspection steps in this service bulletin closely to avoid choosing the incorrect calibration. Choosing the incorrect calibration will result in an undesirable noise from the High Pressure Fuel Pump, requiring the ECM to be flashed again with the correct calibration.**

1. Inspect the fuel injection pump to see which pump the vehicle has:
  - Vehicles with the new style Symmetrical Cam design pump will have one large single dot embossed in the pump housing (Fig. 1) .
  - For vehicles equipped with a Symmetrical Cam pump, choose the calibration labeled Symmetric Cam, or Sym Cam.

1 - One large Single Dot on Housing
